VOLUME 2 OF 2

APPENDICES

APPENDIX 5: WESTHILL HIGH SCHOOL FACILITY CONDITION ASSESSMENT

EXISTING CONDITIONS REPORT

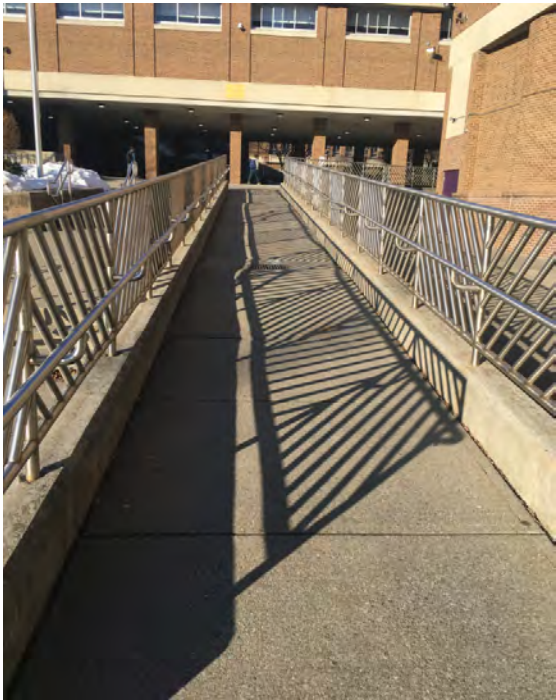
Figure 1

1. The original building and site were constructed in 1971.
2. The ramp entering the main entrance is does not meet ICC/A117.1 Accessible and Usable Building Facilities (ANSI) (Figure 1).
3. Non-code compliant signage (Figure 2).
4. Inadequate drop off drive, parking & paving conditions.
5. Unprotected utilities (Figure 3).
6. Inadequate site lighting.
7. Improper drainage (Figure 4).
8. Pavers badly cracked and heaving in many locations (Figure 5).
9. Badly damaged and cracked brick pavers (Figure 6).
10. Steps in Courtyard does not meet ICC/A117.1 Accessible and Usable Building Facilities (ANSI) with no accessible route (Figure 7).
11. Inadequate lighting under canopies (Figure 8).

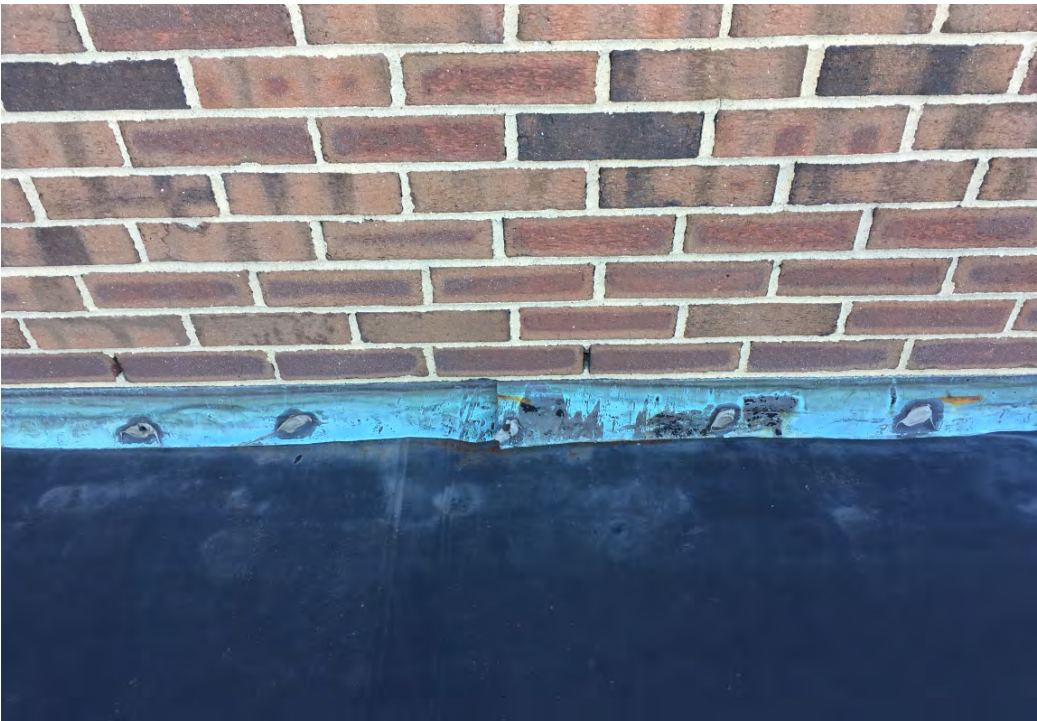
Figure 10

- There is evidence of water ponding and patched areas (Figure 11).
 - Some areas need repairs to the roof flashing at parapets (Figure 10).
 - It is not anticipated to have a life expectancy of another 20 years.

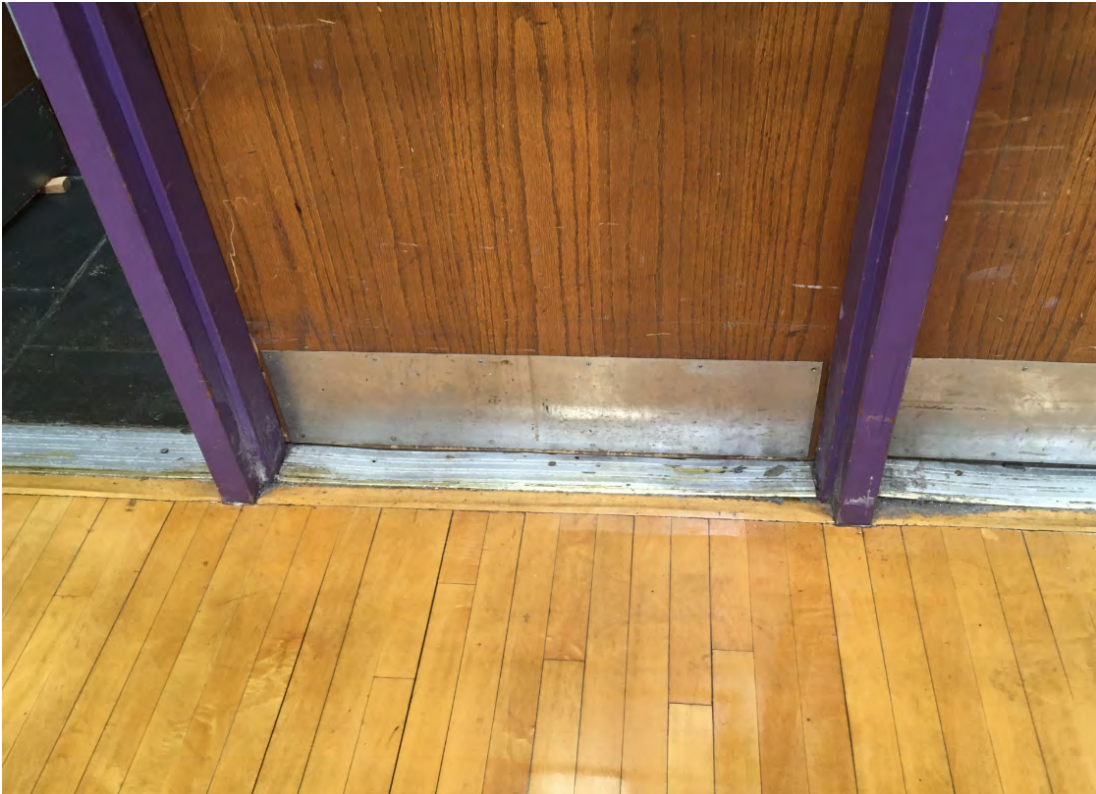
Figure 14

- The Gym has a wood athletic floor on a sleeper system. There is evidence of buckling to many of the planks and is beginning to cause some safety concerns for regular and competition use most noticeably on the perimeter (Figure 14).
- The movable partition in the Gymnasium appears to be damaged and non-operational.

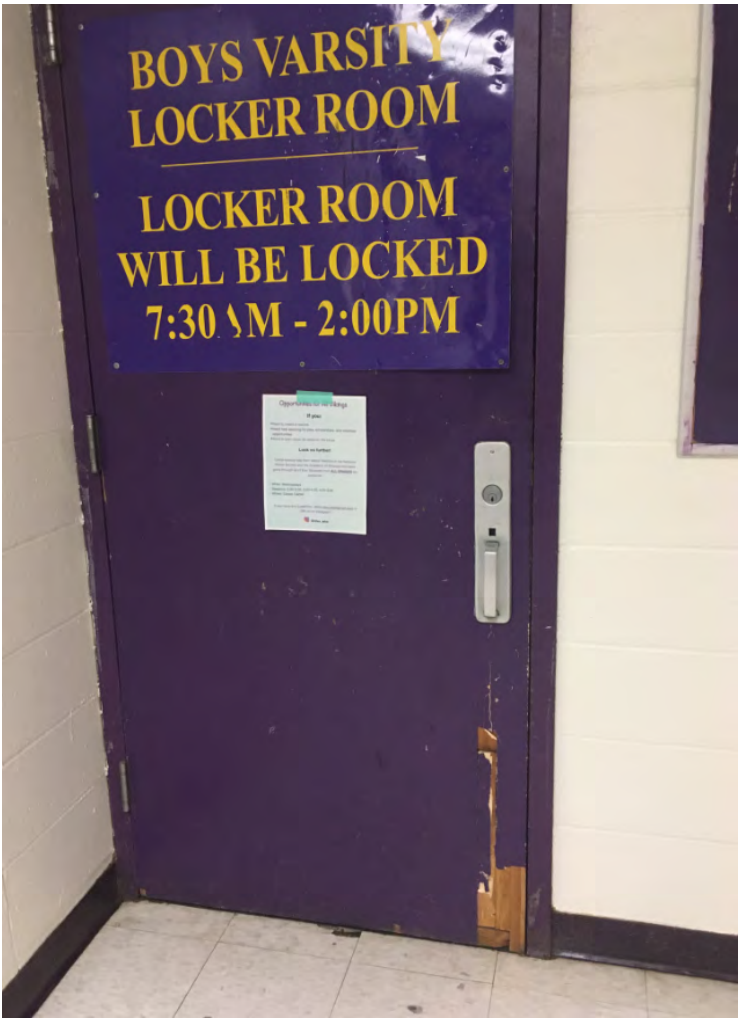
Figure 21

- The Locker Rooms do not meet ICC/A117.1 Accessible and Usable Building Facilities (ANSI). There are no accessible routes (Figure 16), no accessible lockers (Figure 17) and no accessible toilets or showers (Figure 18).
- The Gypsum board ceiling has areas where portions of the ceiling system has been removed to access above ceiling equipment (Figure 19).
- The terrazzo shower bases and ceramic shower tiles are badly stained and damaged beyond repair and need to be replaced (Figure 20).
- Wood doors are delaminating and need to be replaced throughout (Figure 21).

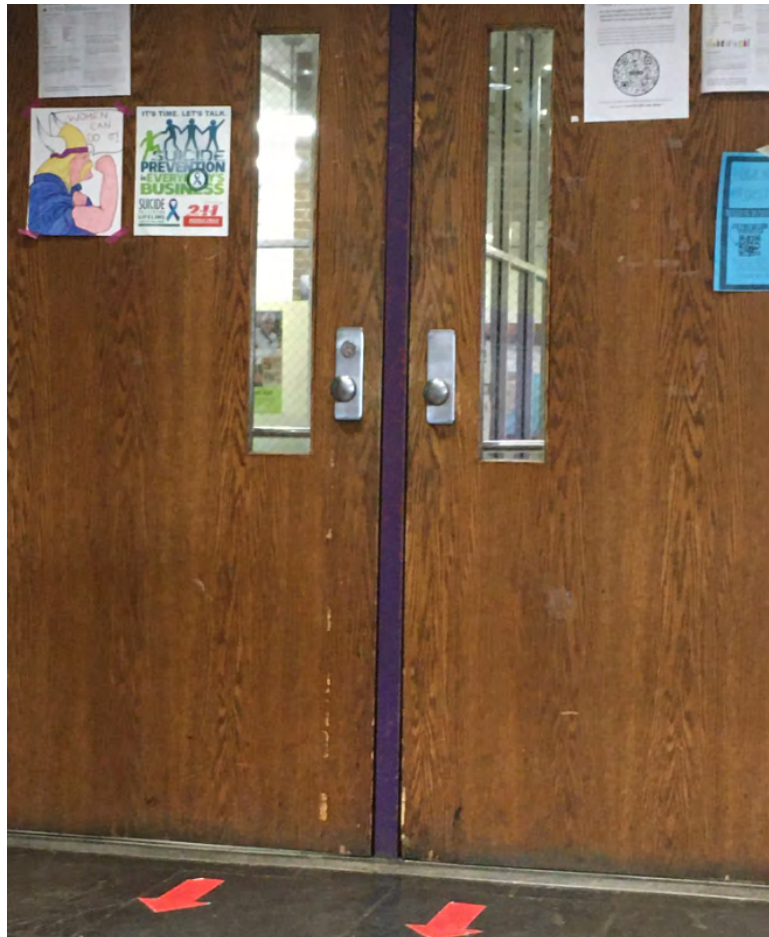
Figure 24

- Doors and door hardware in most locations does not comply with ICC/A117.1 Accessible and Usable Building Facilities (ANSI) and contains wire glass which is no longer allowable in school facilities (Figure 24).

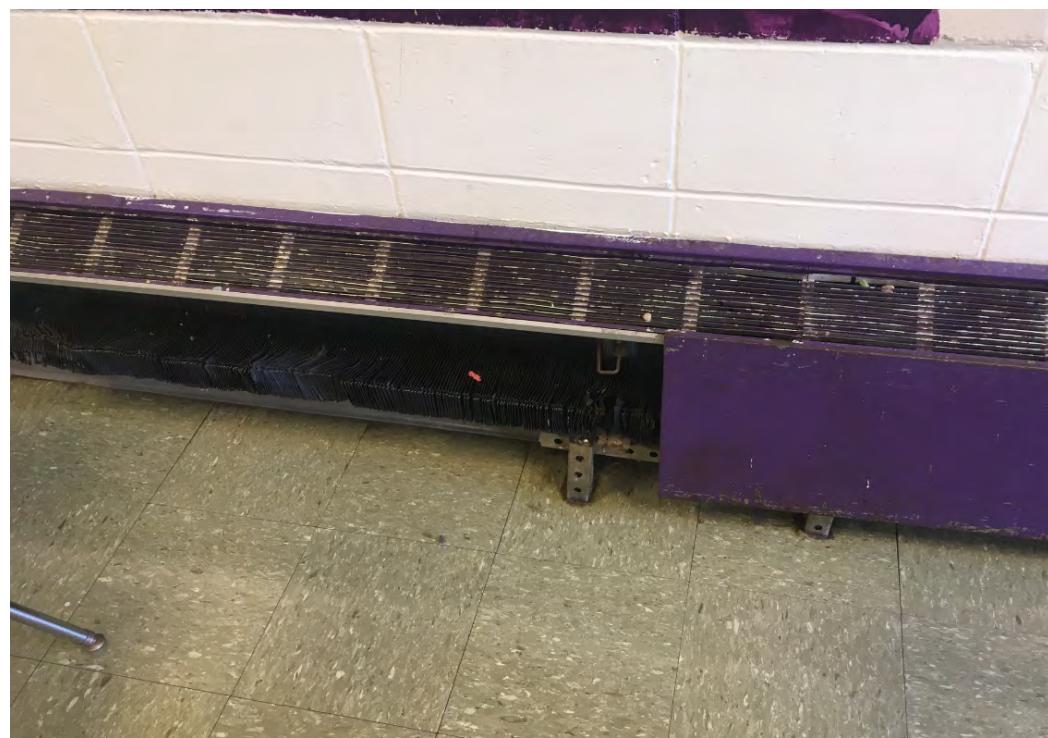
Figure 25

- Radiant heating panels are badly damaged and missing covers (Figure 25).
- The serving areas snack bars were renovated in 2011 but most of the current kitchen equipment is outdated and/or not working.

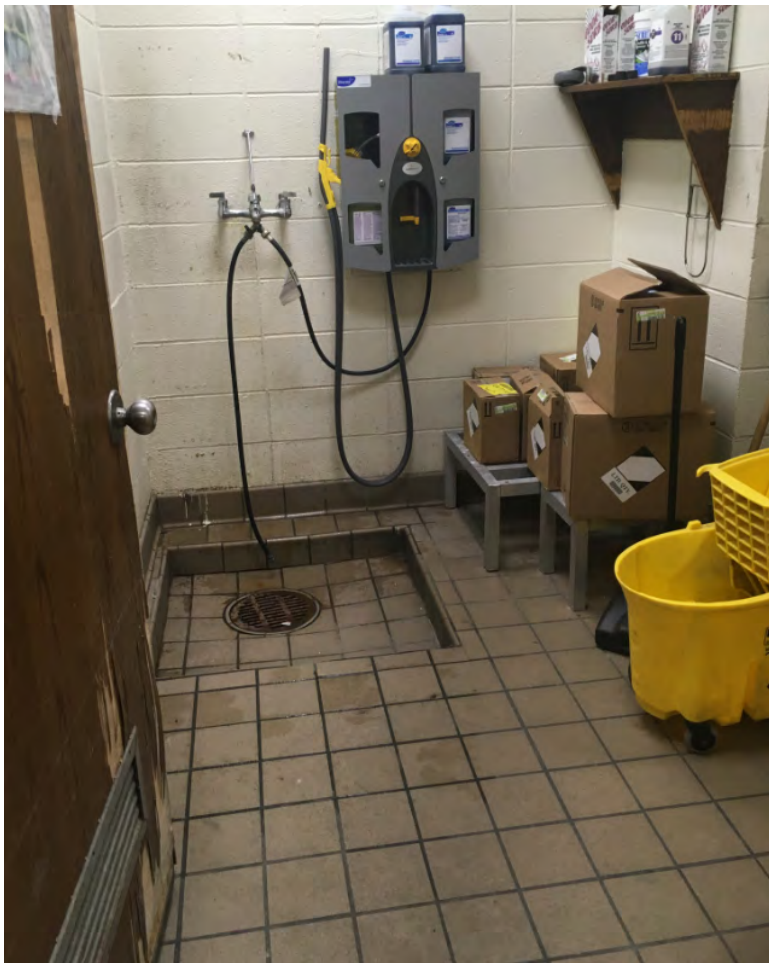
Figure 26

- Kitchen equipment in most locations does not comply with ICC/A117.1 Accessible and Usable Building Facilities (ANSI).
- Wood doors are delaminating and need to be replaced throughout (Figure 26).

- The quarry tile is badly worn, stained and cracked in several locations and needs to be replaced (Figure 26).

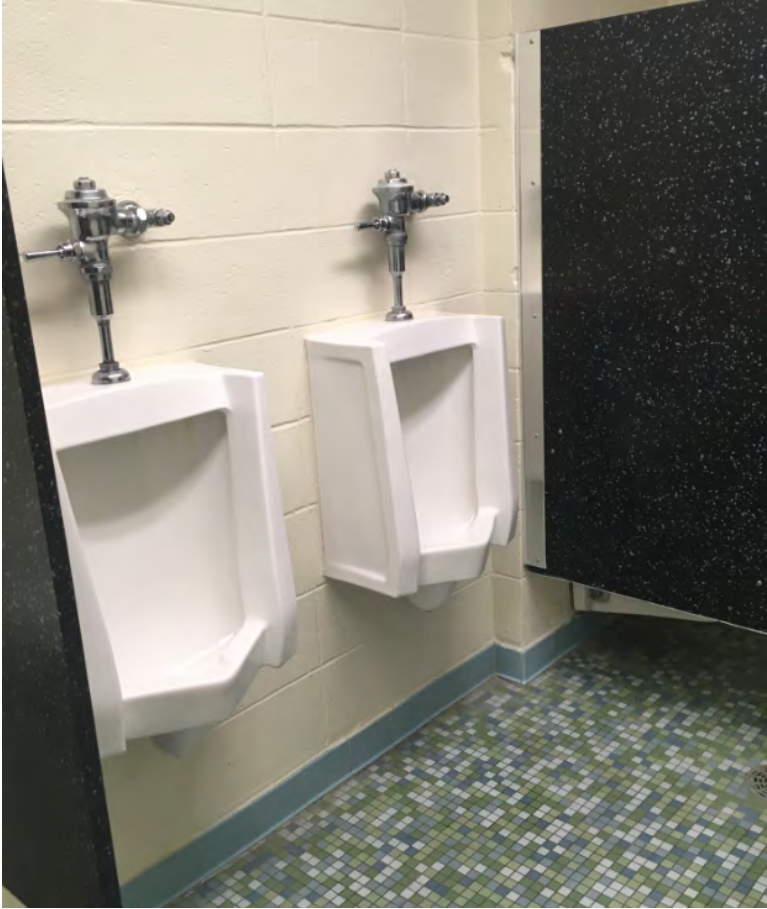
Figure 33

- Wall base missing in many locations (Figure 29).
 - Toilet Rooms do not comply with ICC/A117.1 Accessible and Usable Building Facilities (ANSI) (Figure 31) (Figure 32) (Figure 33).

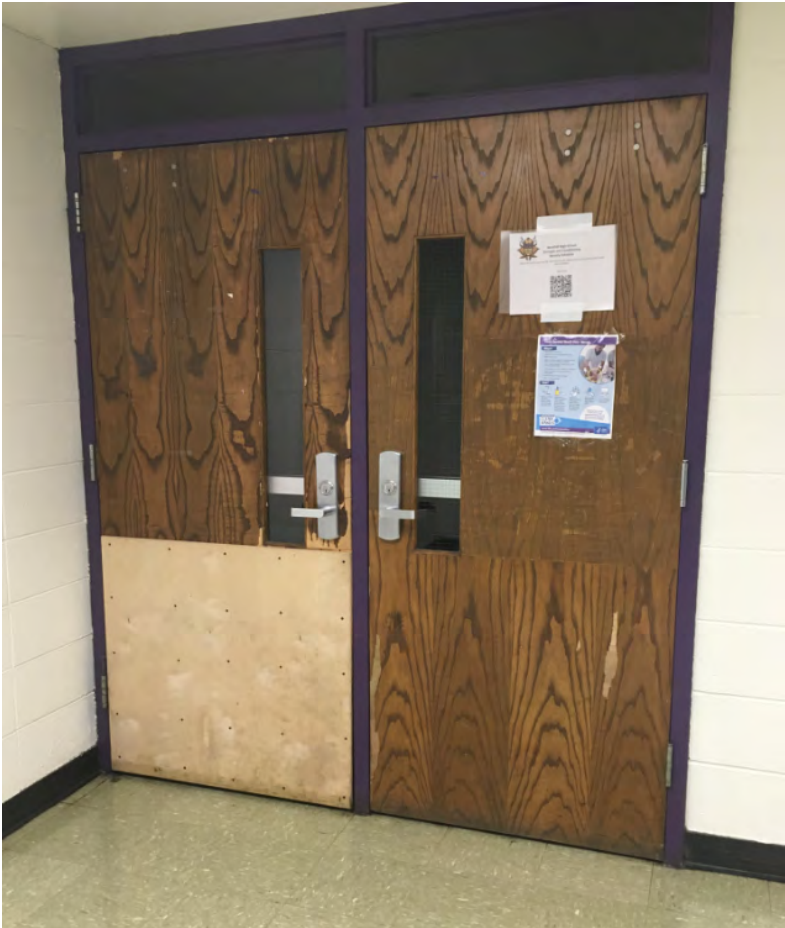
Figure 35

- Doors and door hardware broken and/or damaged in many locations (Figure 34) (Figure 35).
- Wall base missing in several locations (Figure 36).
- Shop equipment outdated and doesn't meet OSHA compliant requirements.

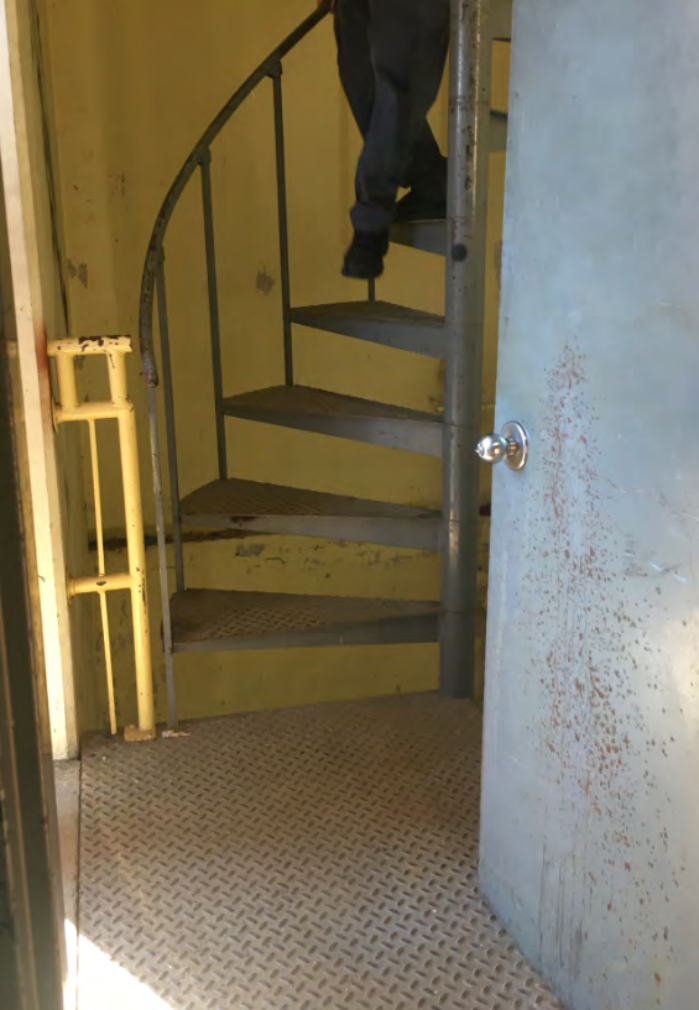
Figure 40

- Doors rusted and does not comply with ICC/A117.1 Accessible and Usable Building Facilities (ANSI) (Figure 40).
- Contains combustible material wood partitions (Figure 41).
- Wood flooring badly damaged and scratched (Figure 42).

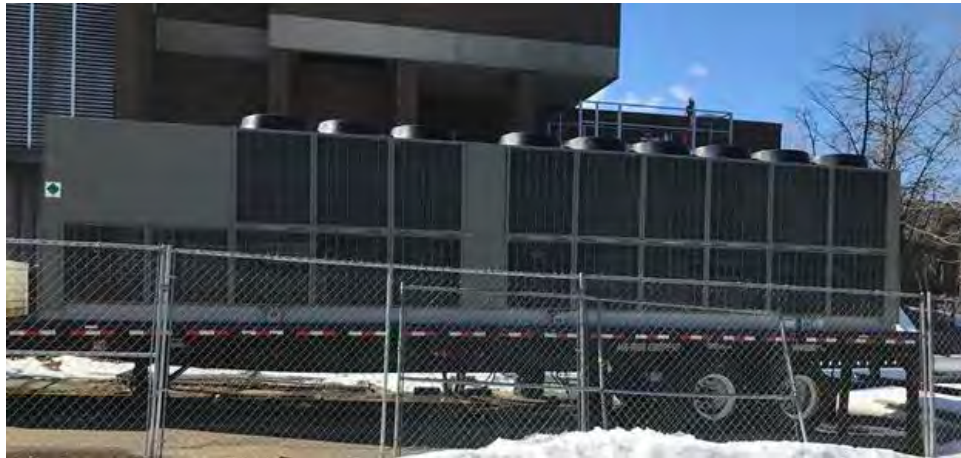
Figure H-1 - Site

1. The theatre on the east side of Building 3 has a site located temporary outdoor air-cooled chiller mounted on a trailer (Figures H-1 and H-2).
2. Outdoor Chiller replaced indoor chiller that had a failure and is sitting abandoned in the chiller mechanical room in Building 3.

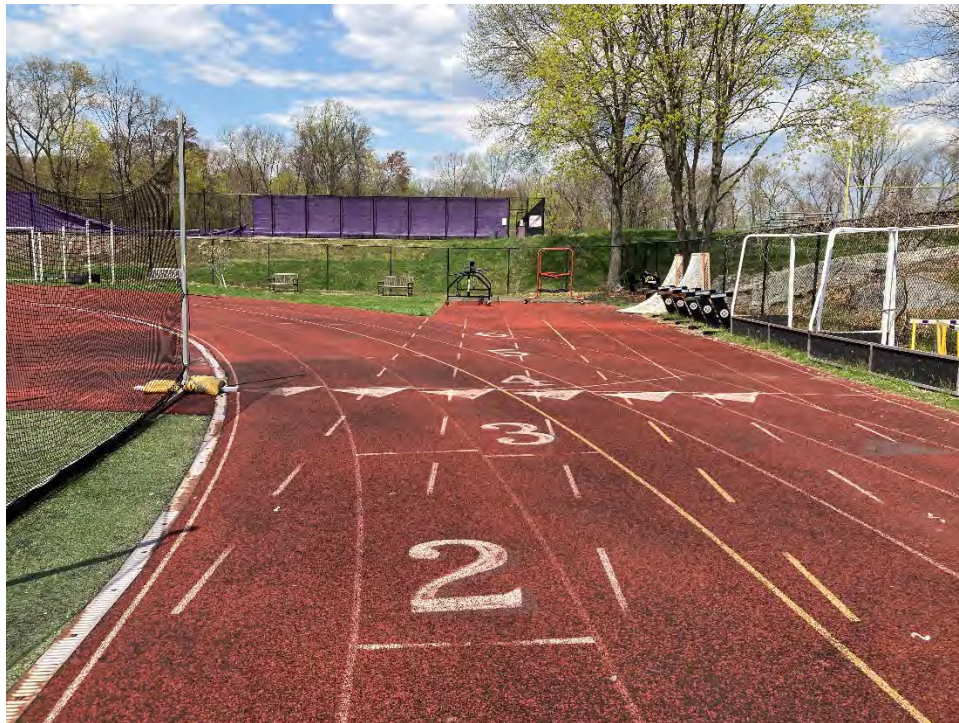
Photo 8: Worn Running Track
