VOLUME 2 OF 2

APPENDICES

APPENDIX 5: WESTHILL HIGH SCHOOL FACILITY CONDITION ASSESSMENT

EXISTING CONDITIONS REPORT

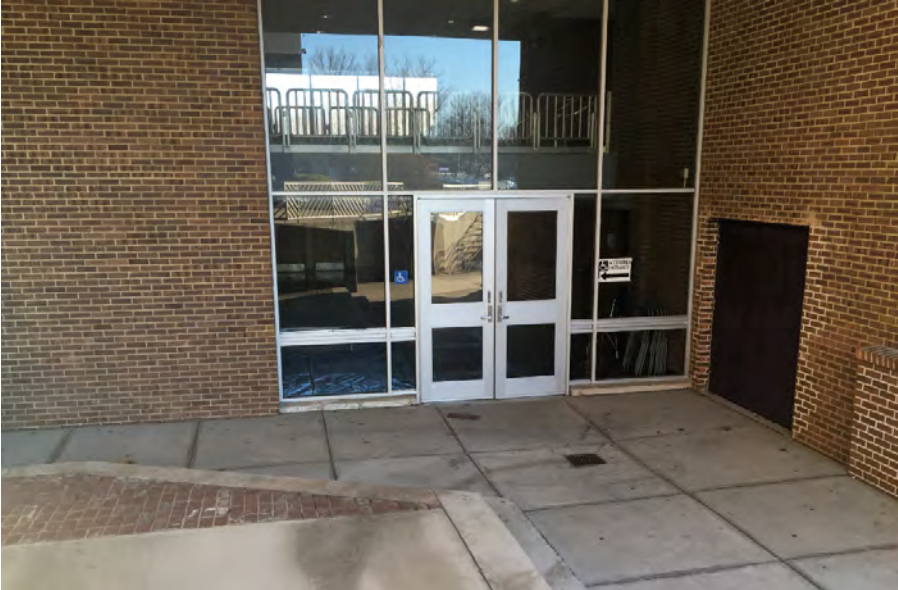
Figure 2

1. The original building and site were constructed in 1971.
2. The ramp entering the main entrance is does not meet ICC/A117.1 Accessible and Usable Building Facilities (ANSI) (Figure 1).
3. Non-code compliant signage (Figure 2).
4. Inadequate drop off drive, parking & paving conditions.
5. Unprotected utilities (Figure 3).
6. Inadequate site lighting.
7. Improper drainage (Figure 4).
8. Pavers badly cracked and heaving in many locations (Figure 5).
9. Badly damaged and cracked brick pavers (Figure 6).
10. Steps in Courtyard does not meet ICC/A117.1 Accessible and Usable Building Facilities (ANSI) with no accessible route (Figure 7).
11. Inadequate lighting under canopies (Figure 8).

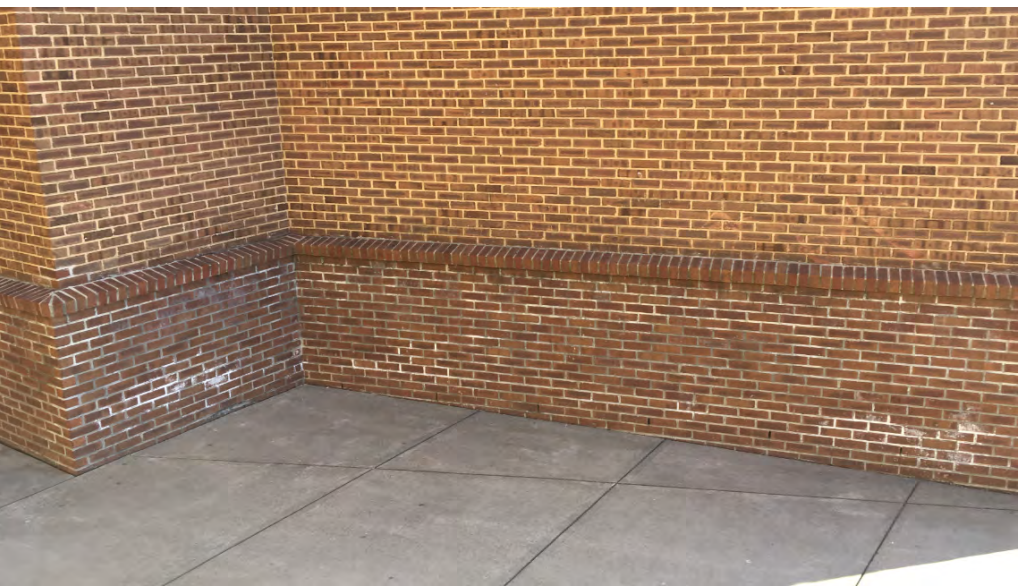
Figure 9

- The 2" rigid insulation with 2" air space does not meet the current energy code.
 - Areas of exterior brick need repointing (Figure 9).
 - Several locations with efflorescence damaged brick (Figure 9).

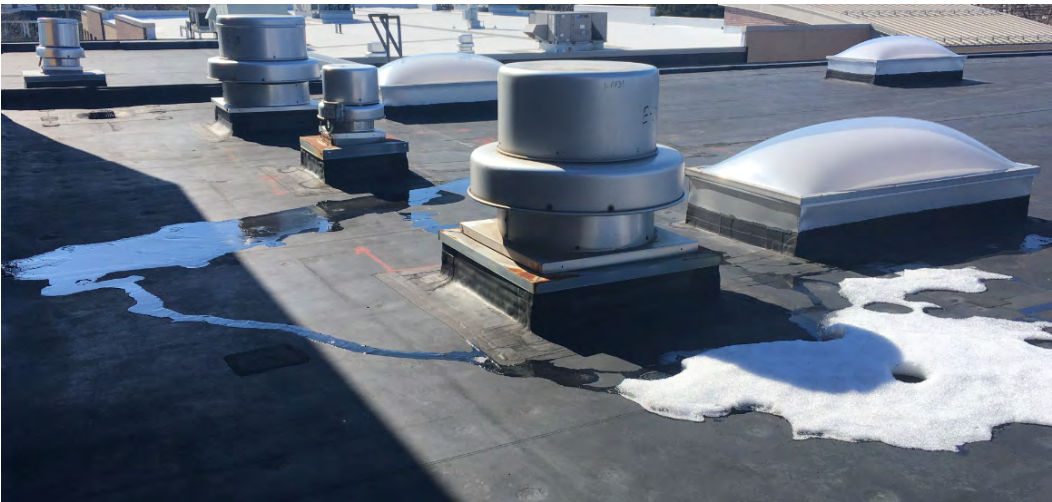
Figure 11

- There is evidence of water ponding and patched areas (Figure 11).
 - Some areas need repairs to the roof flashing at parapets (Figure 10).
 - It is not anticipated to have a life expectancy of another 20 years.

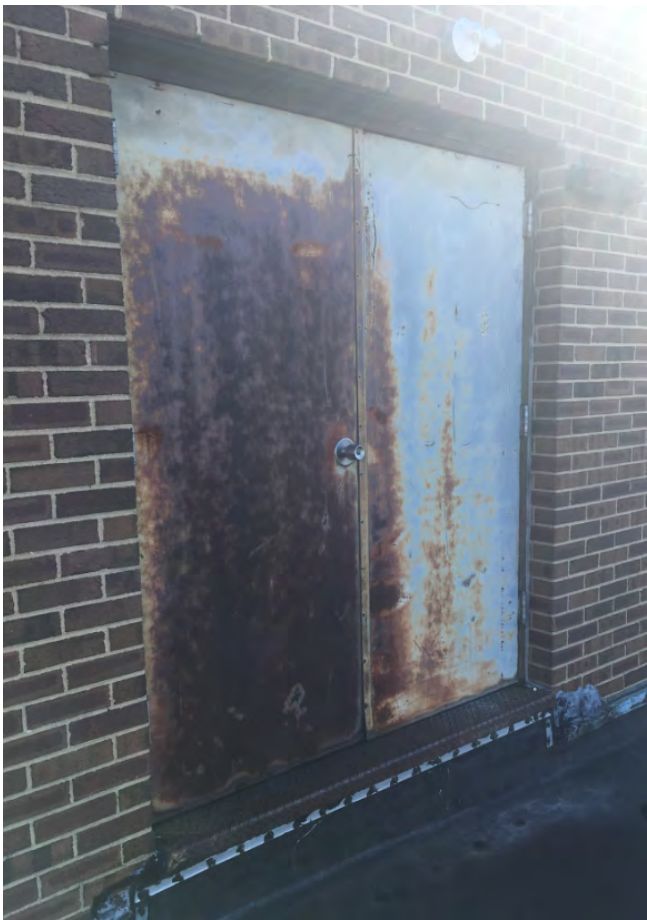
Figure 12

- Exterior doors to mechanical spaces are severely rusted (Figure 12).
 - Membrane in some areas appear to have been badly damaged in winter storm and is torn up from rigid insulation (Figure 13).

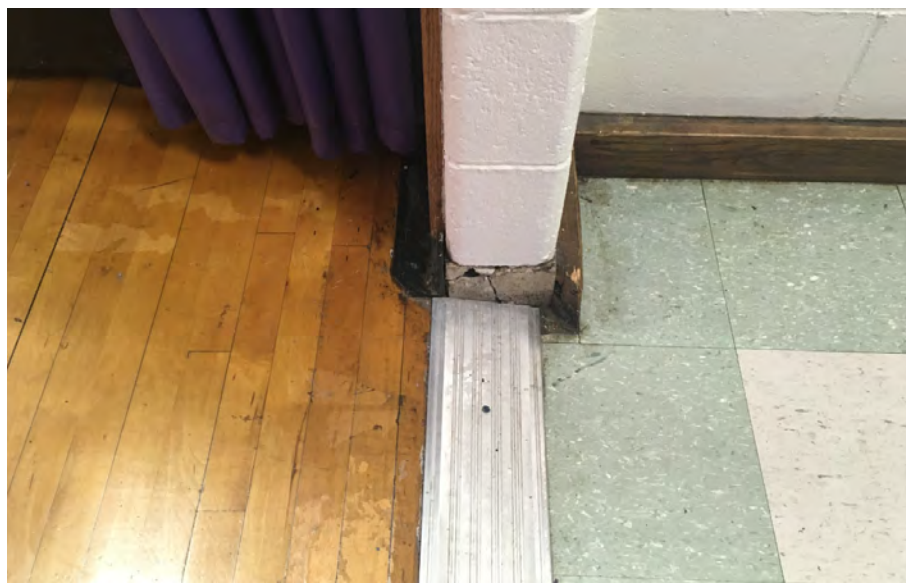
Figure 15

- Existing flooring system Vinyl Composite Tile (VCT). It is not anticipated to have a life expectancy of another 20 years and should be replaced with new flooring material. There are many areas of the building where repair patches are evident and do not match the original materials (Figure 15).

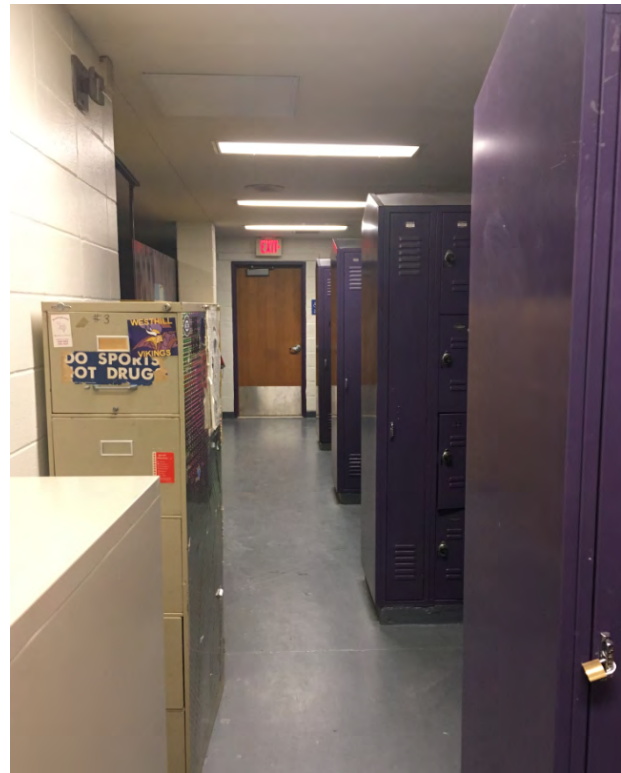
Figure 16

- The Locker Rooms do not meet ICC/A117.1 Accessible and Usable Building Facilities (ANSI). There are no accessible routes (Figure 16), no accessible lockers (Figure 17) and no accessible toilets or showers (Figure 18).
- The Gypsum board ceiling has areas where portions of the ceiling system has been removed to access above ceiling equipment (Figure 19).
- The terrazzo shower bases and ceramic shower tiles are badly stained and damaged beyond repair and need to be replaced (Figure 20).
- Wood doors are delaminating and need to be replaced throughout (Figure 21).

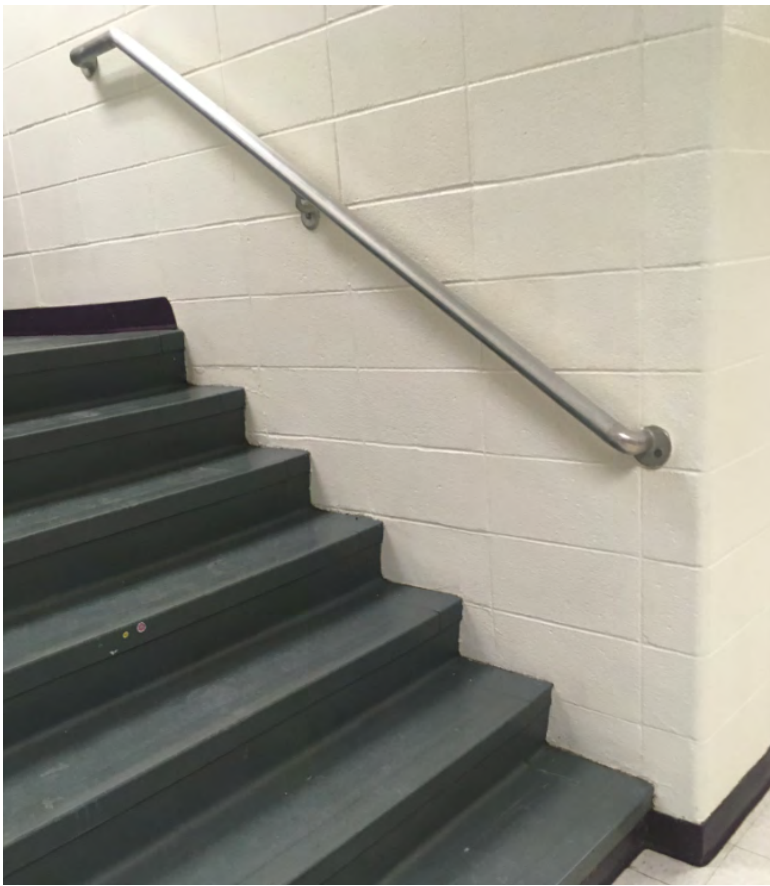
Figure 22

- Handrails at stairs do not comply with ICC/A117.1 Accessible and Usable Building Facilities (ANSI) (Figure 22).
 - Signage throughout does not comply with ICC/A117.1 Accessible and Usable Building Facilities (ANSI) (Figure 23).

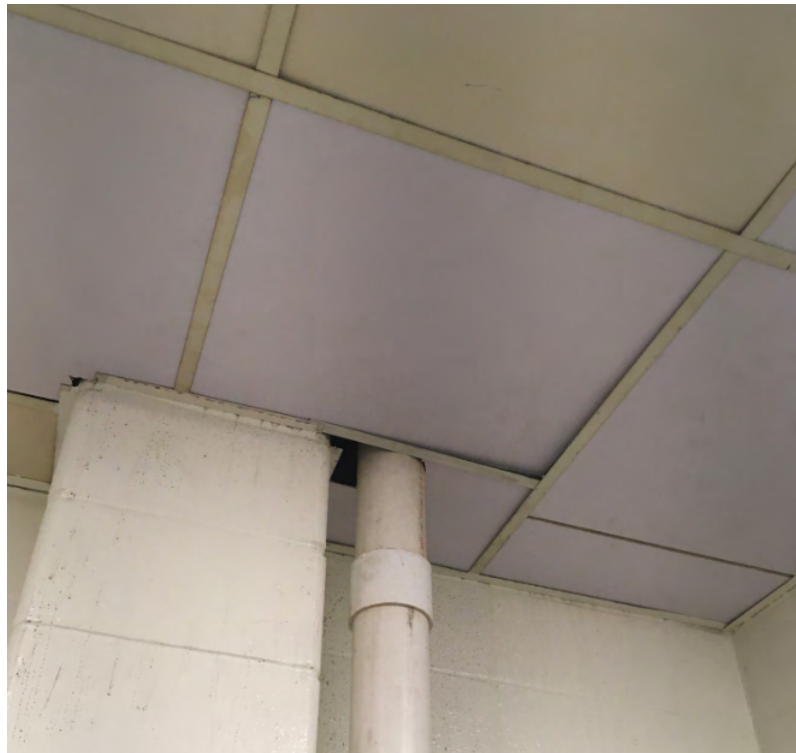
Figure 27

- Acoustical tile ceiling system (ACT) in Kitchen has exceeded its life expectancy, has several missing and/or broken tiles, has been patched with improper tiles for this area and needs to be replaced with a new washable ceiling tile (Figure 27).

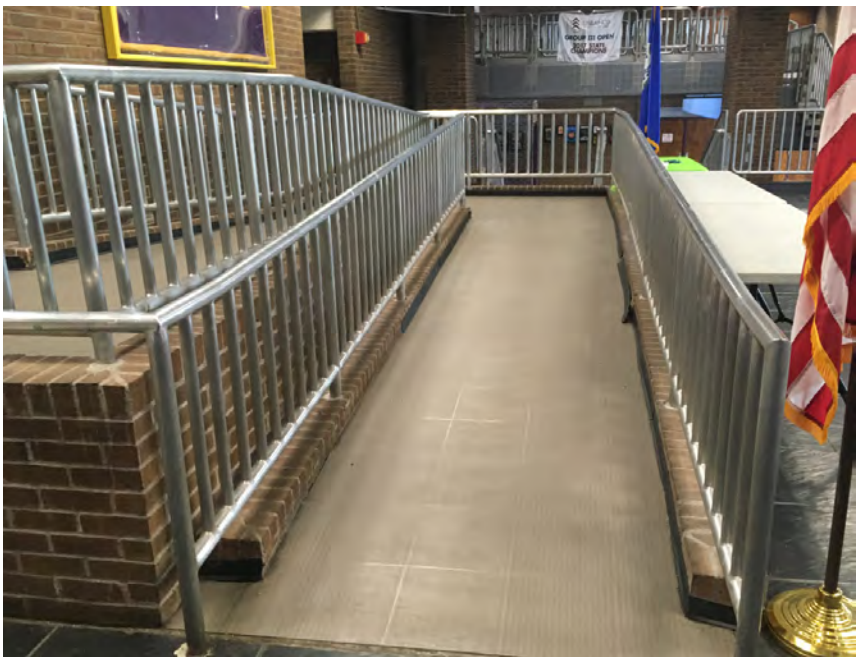
Figure 28

- Handrails at stairs do not comply with ICC/A117.1 Accessible and Usable Building Facilities (ANSI) (Figure 28).
 - Signage throughout does not comply with ICC/A117.1 Accessible and Usable Building Facilities (ANSI) (Figure 30).

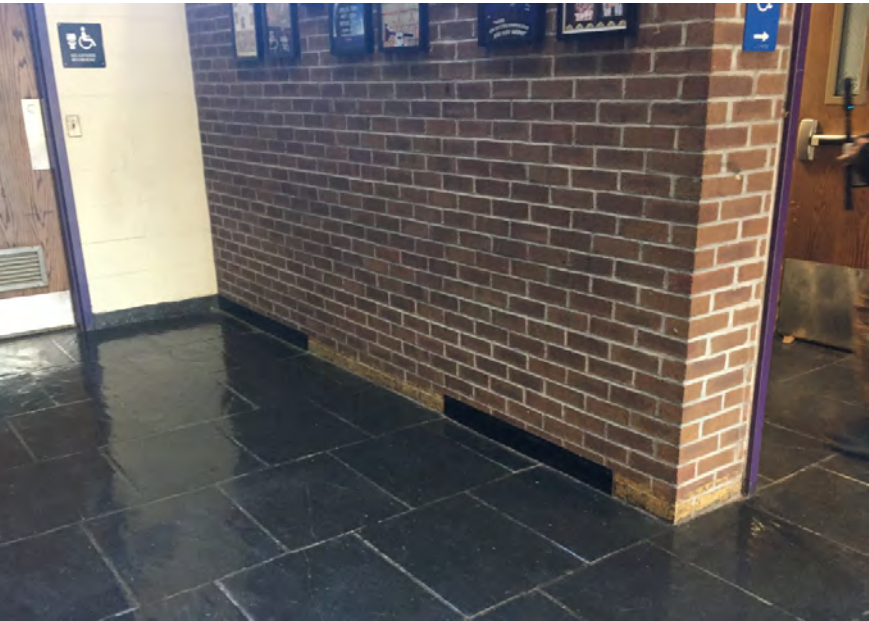
Figure 29

- Wall base missing in many locations (Figure 29).
 - Toilet Rooms do not comply with ICC/A117.1 Accessible and Usable Building Facilities (ANSI) (Figure 31) (Figure 32) (Figure 33).

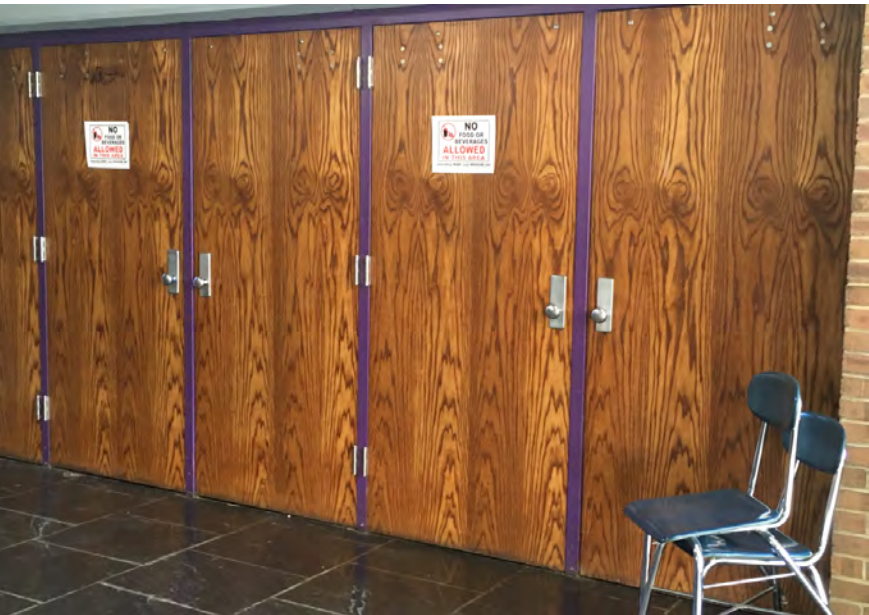
Figure 30

- Doors and door hardware in most locations does not comply with ICC/A117.1 Accessible and Usable Building Facilities (ANSI) and contains wire glass which is no longer allowable in school facilities (Figure 30).

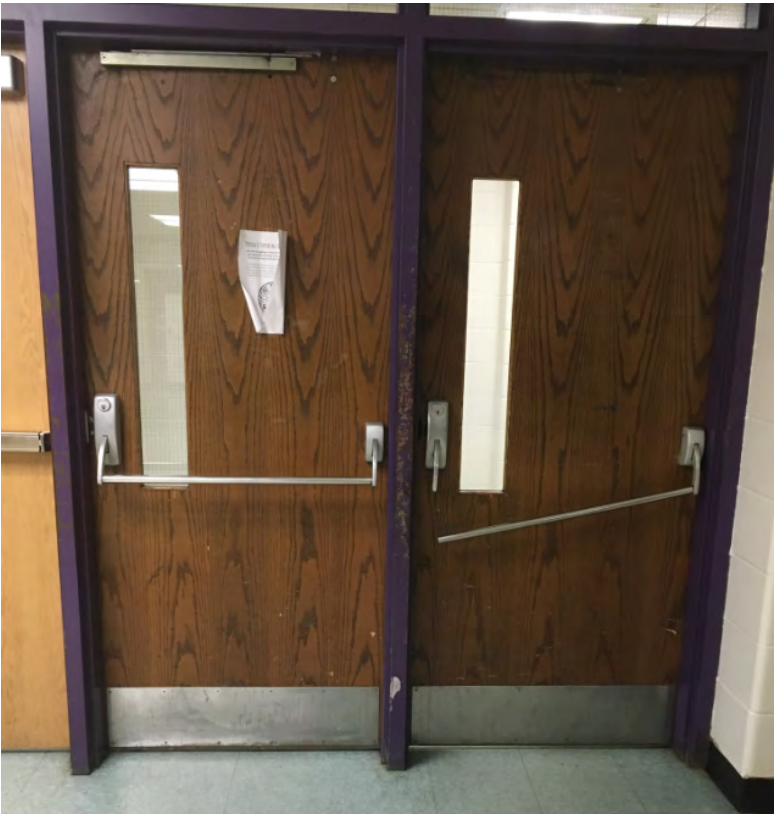
Figure 34

- Doors and door hardware broken and/or damaged in many locations (Figure 34) (Figure 35).
- Wall base missing in several locations (Figure 36).
- Shop equipment outdated and doesn't meet OSHA compliant requirements.

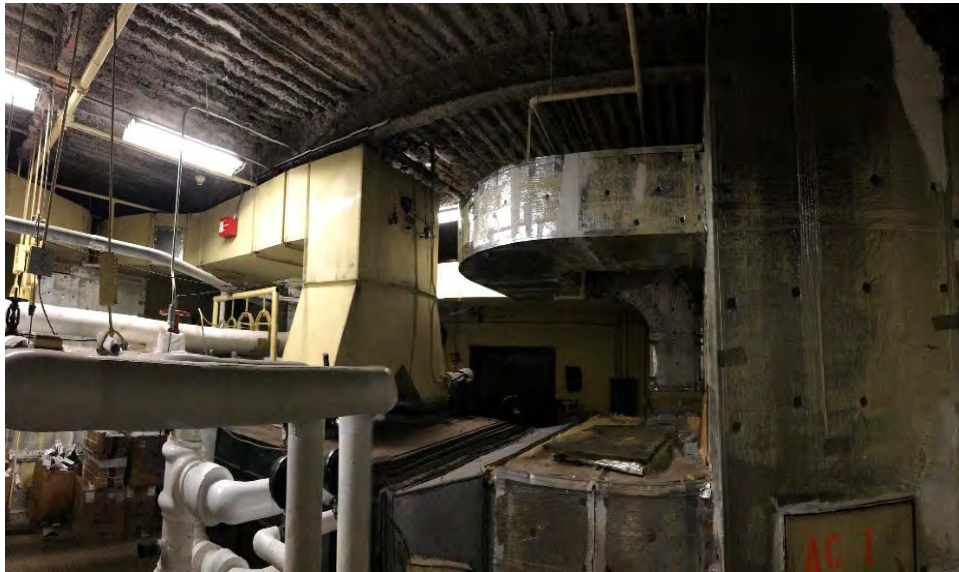
Figure H-26 - Building 3

- Main Office and Media Center are served by separate by similar units located in Penthouse A. The units are labeled AC-1, AC-2 (Figure H-27), and AC-3. The spaces are cooled, heated, and ventilated and are served by indoor air-handlers with hot water heating coils, chilled water cooling coils, supply fan, return and outdoor ventilation. There are separate ducted return fans associated with the air-handlers. The unit components appear to be in poor condition and are all beyond their expected useful life. Flexible duct connectors are torn and the casing has substantial air leaks (Figure H-26).

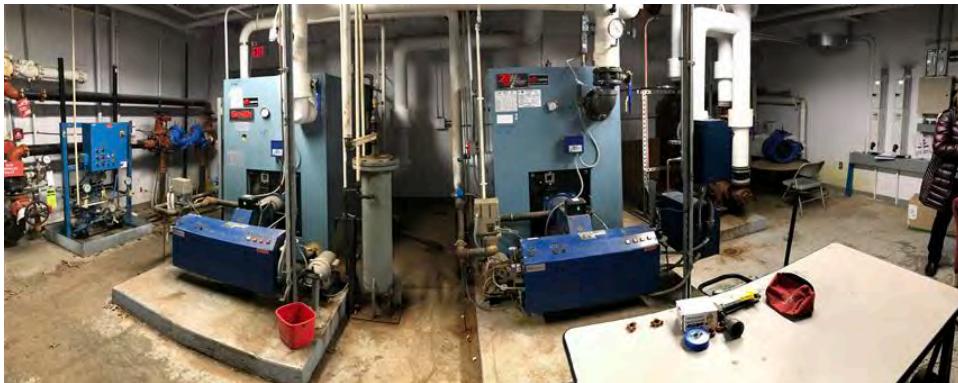
Figure H-35 - Building 5

- There are two separate boiler rooms, Main Mechanical (Figure H-35) and Greenhouse Mechanical Room (Figure H-36). Both mechanical room have two Smith cast-iron boilers, each with dual fuel Power Flame burners. All boilers appear to be in good condition.
 - Pumps have prominent rusting around volutes and nearby pipe fittings (Figures H-37 and H-38).

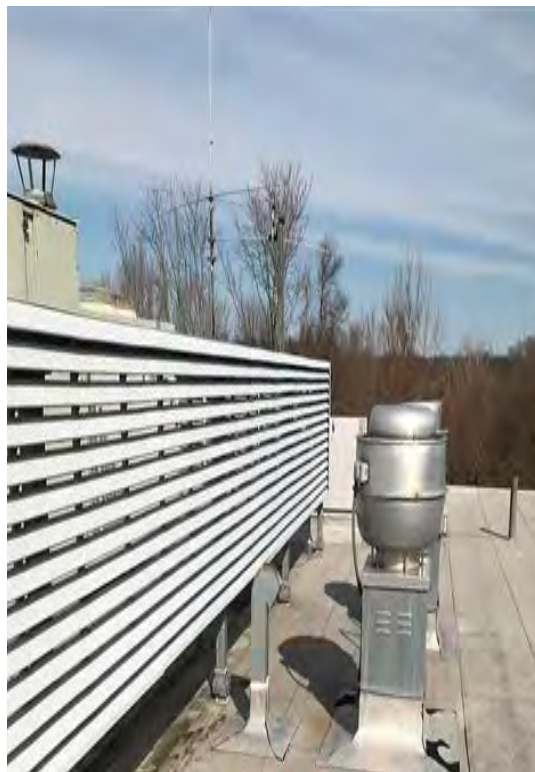
Figure H-39 - Building 5

- The high roof has one large Trane Intellipak packaged rooftop unit with DX cooling, heating and ventilation (Figure H-39). There are multiple mushroom down-blast and up-blast rooftop fans (Figure H-40). The rooftop unit and fans appear to be in fair condition. Surface rust is visible on the DX condenser fan components (Figure H-41).
- The lower roof has a BKM heat recovery unit (Figure H-42) and two small Trane rooftop units (Figure H-43) with heating, cooling, and ventilation. There are rooftop mushroom exhaust fans, up-blast and down-blast. All units appear to be in fair condition and approaching the end of their expected useful life.
- The greenhouse has several side wall propeller exhaust fans.

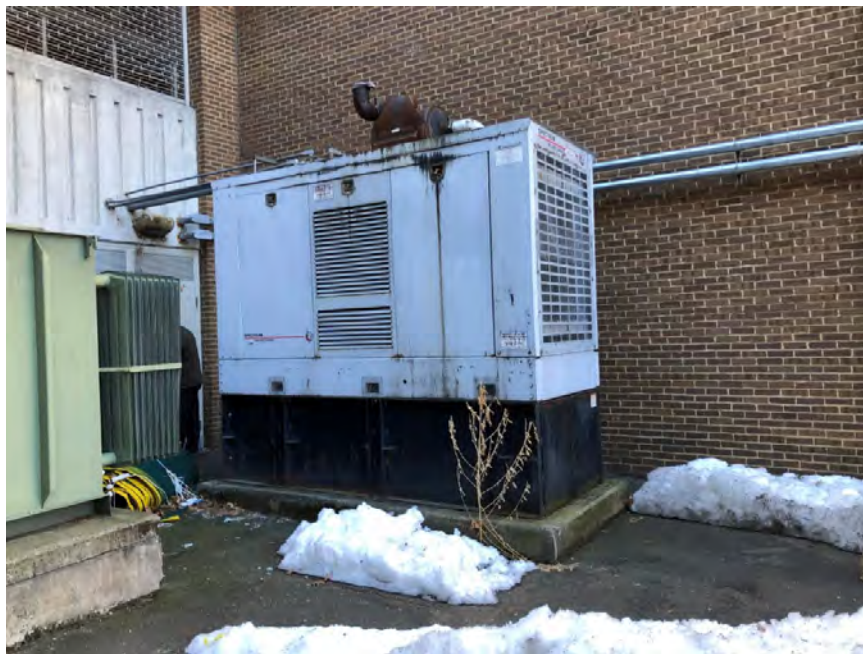
- generator is unknown at this time. Generator is manufactured by Spectrum Detroit diesel. Generator is in fair to poor condition (Figure E-2).
3. On the exterior of the building, there are wall-mounted HID or LED lighting fixtures, which are not full cut-off type lighting fixtures. They are in fair to poor condition.
 4. There are site pole arm-mounted architectural style LED lighting fixtures in the parking lot and site. They are in fair condition.
 5. Exterior lightings are controlled by time clock, photocell and multi-pole contractors.

Figure E-2 Site-Mounted Generator Serving Fire Pump Located in Mechanical Room on Lower Level of Building 3

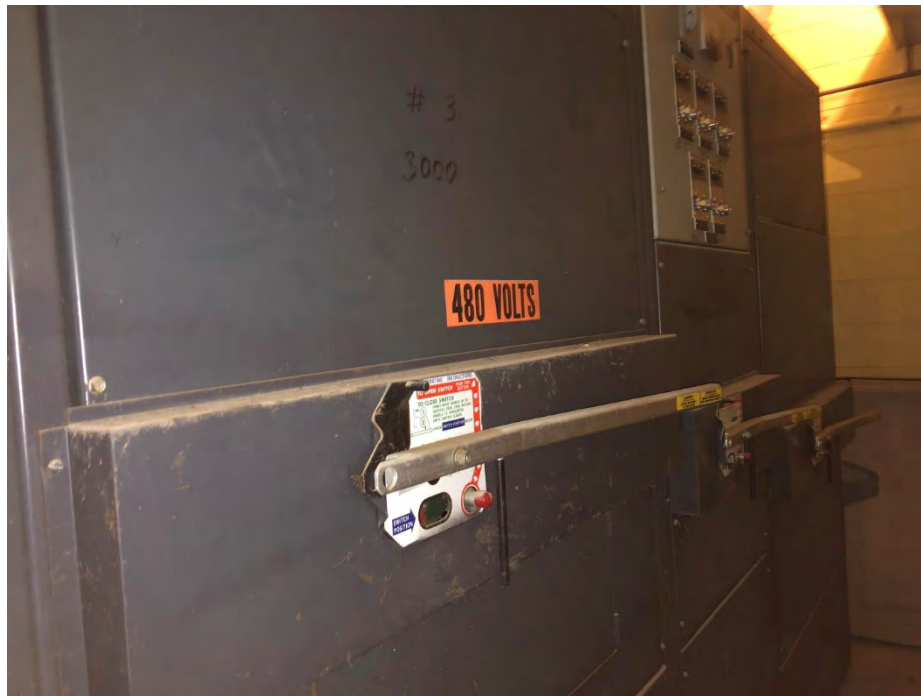
- The main switchboard was installed under the original building construction. It is in poor condition.
 - There is a 400A disconnect switch side-mounted on the switchboard serving the Concession panel located in site Concession booth.

Figure E-3 Main Switchboard MDB-2 Located in Switchboard Room on Lower Level of Building 2

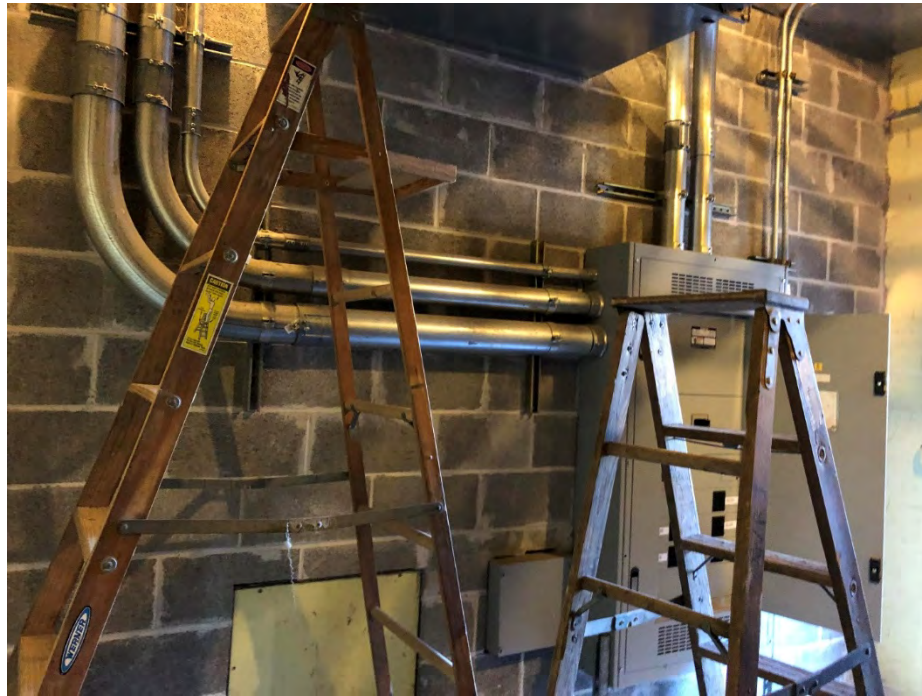
- The existing main switchboard is serving various panelboards and transformers in Building 2 and Building 4. It is also serving kitchen panelboards.
 - There is a 1000A, 480Y/277V, 3-phase, 4-wire distribution panel (DP-1) located in the switchgear room on the lower level which is serving panelboards located throughout Building 1 and Building 2A. Distribution panel DP-1 was installed under a 2007 construction project. It is in good condition. It is fed from existing switchboard MDB2 (Figure E-5).

Figure E-5 1000A Distribution Panelboard DP-1 located in Switchgear Room on Lower Level in Building 2

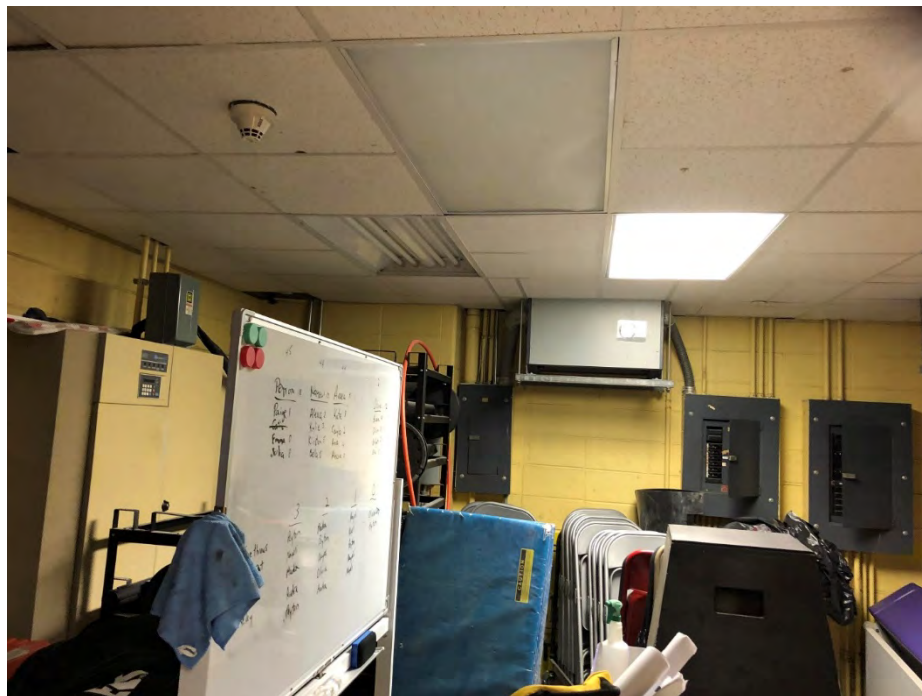
- There is an existing central emergency lighting inverter system located in the storage room adjacent to the old Gym. Exact installation date is unknown. It is in poor condition. There are emergency lighting panels located in this storage room serving emergency lighting and exit signs in the path of egress area and selected areas in Building 2 (Figure E-5).
- There are some wall-mounted emergency lighting units serving as emergency lighting in selected areas. They are in poor condition.
- Emergency lighting is served by a central emergency lighting inverter system and wall- and/or ceiling-mounted standalone emergency lighting units.

Figure E-6 Central Emergency Lighting Inverter System and Electrical Distribution System Located in Storage Room Adjacent to Gym in Building 2

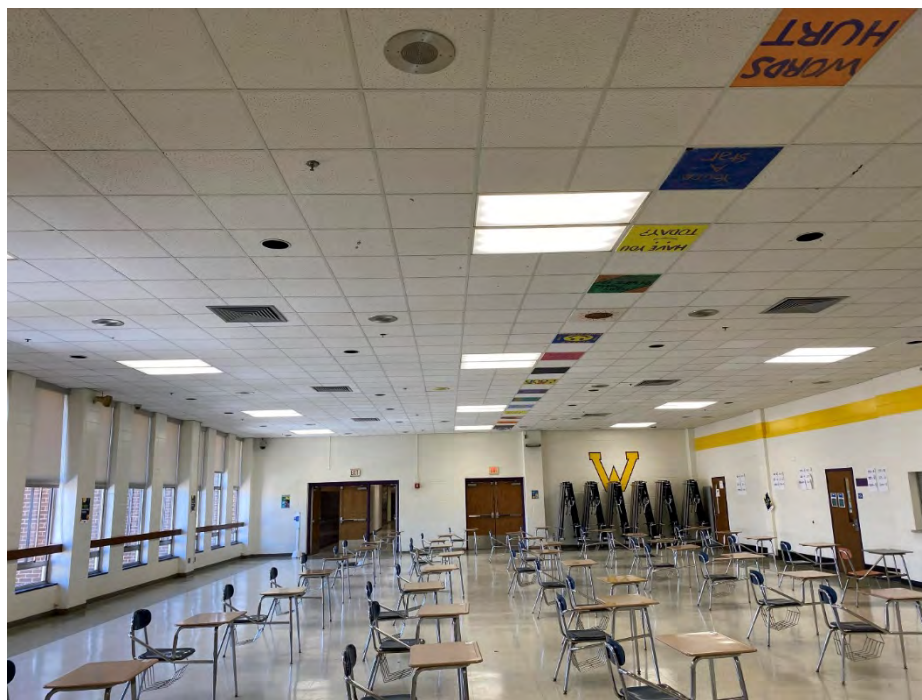
- The lighting in general consist of 2'x4', 2'x2' and 1'x4' recessed ceiling-mounted prismatic lens fixtures with retrofitted LED lamps throughout Building 2 (Figure E-8).
- There are some industrial strip lighting fixtures in the storage room and utility rooms.
- There are pendant-mounted 2'x4 industrial type lighting fixtures with wire guard with retrofitted LED lamps in the Gymnasium (Figure E-7).
- The lighting in most areas is in fair to poor condition.
- Lighting in most areas is controlled by local wall-mounted switches.
- Lighting in corridors or public areas is controlled by local wall-mounted keyed switches.

Figure E-8 Lighting in General in Building 2

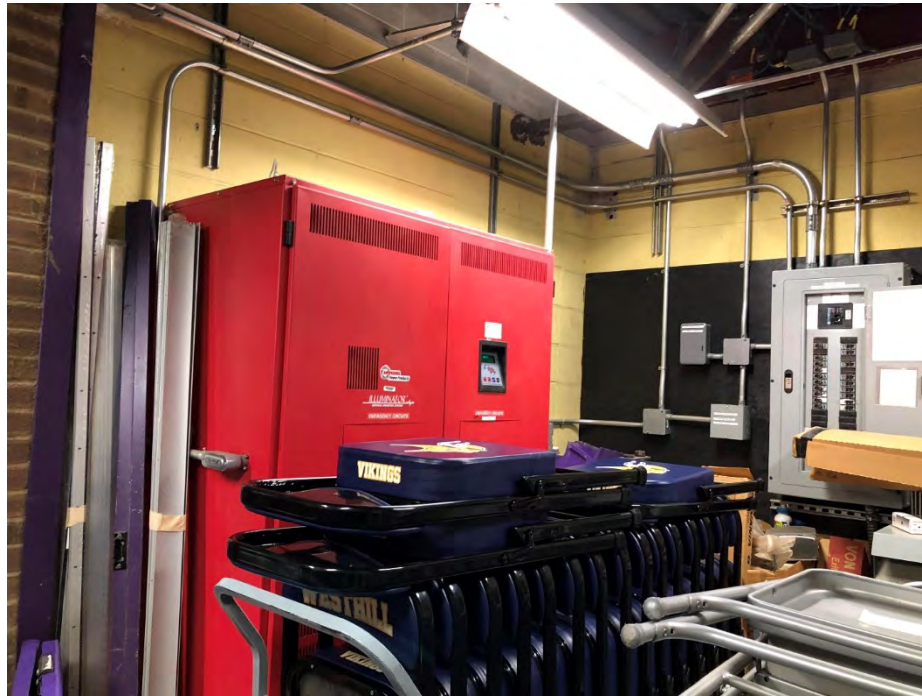
3. Electrical Service and Distribution Systems:
 - Some electrical distribution consists of 480Y/277V, 3-phase, 4-wire and 208Y/120V 3-phase, 4-wire panelboards and stepdown transformers installed under the 2007 construction project in the electrical room adjacent to the Aux. Gymnasium in Building 2 which are serving Building 2A. They are in good condition (Figures E-9 and E-10).

Figure E-9 Central Emergency Lighting Inverter System and Electrical Distribution System for Building 2 Located in Building 2A

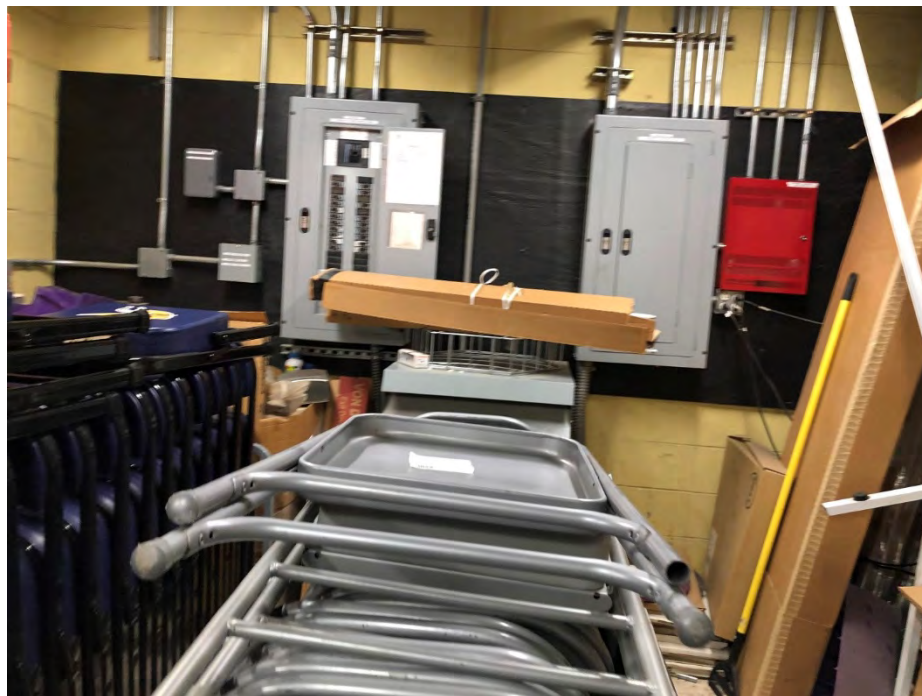
Figure E-10 Electrical Distribution System and Fire Alarm Booster Panel for Building 2 Located in Building 2A

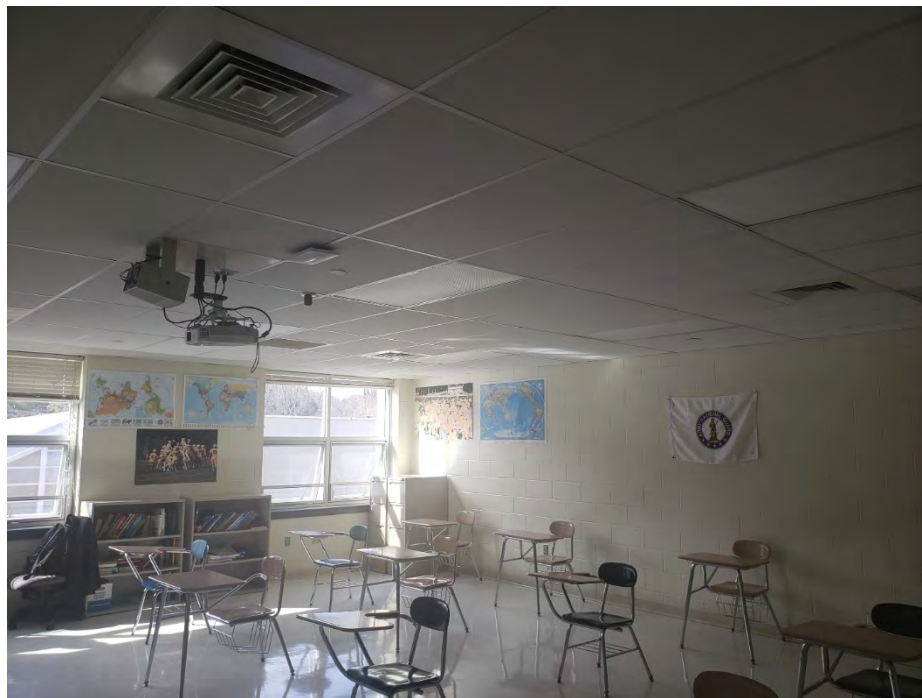
- The lighting in general consist of 2'x4', 2'x2' and 1'x4' recessed ceiling-mounted prismatic lens fixtures with retrofitted LED lamps throughout Building 2A (Figure E-11A).
- There are some industrial strip lighting fixtures in the storage room and utility rooms.
- There are pendant-mounted 2'x2' industrial type lighting fixtures with wire guard with retrofitted LED lamps and built-in occupancy sensor in the Gymnasium (Figure E-11).
- The lighting in most areas is in good condition.
- Lighting in most areas is controlled by occupancy sensors and local wall-mounted switches.
- Lighting in corridors or publics areas is controlled by local wall-mounted keyed switches.

Figure E-11A Lighting in General in Building 2A

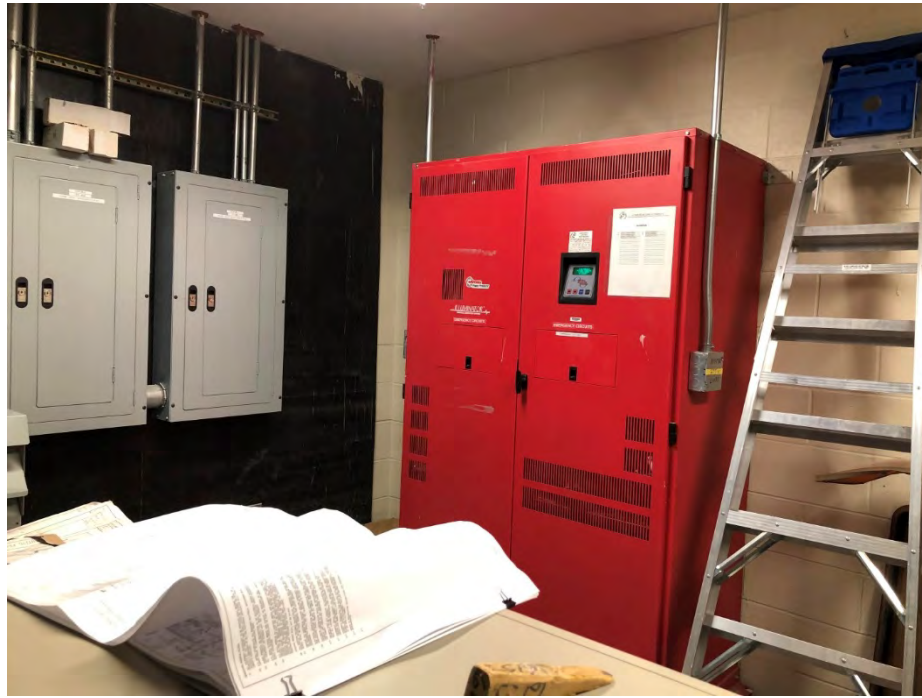
3. Electrical Service and Distribution Systems:
 - The electrical distribution consist of 480Y/277V, 3-phase, 4-wire and 208Y/120V, 3-phase, 4-wire panelboards and stepdown transformers installed under the 2007 construction project in the electrical room on the main level. There are additional 480Y/277V, 3-phase, 4-wire and 208Y/120V 3-phase, 4-wire panelboards located on an upper level. They are in good condition. The 480Y/277V, 3-phase, 4-wire panelboards are fed from distribution panel DP-1 located in the switchgear room in Building 2 (Figures E-12 and E-13).

Figure E-12 Central Emergency Lighting Inverter System and Electrical Distribution System in Building 1

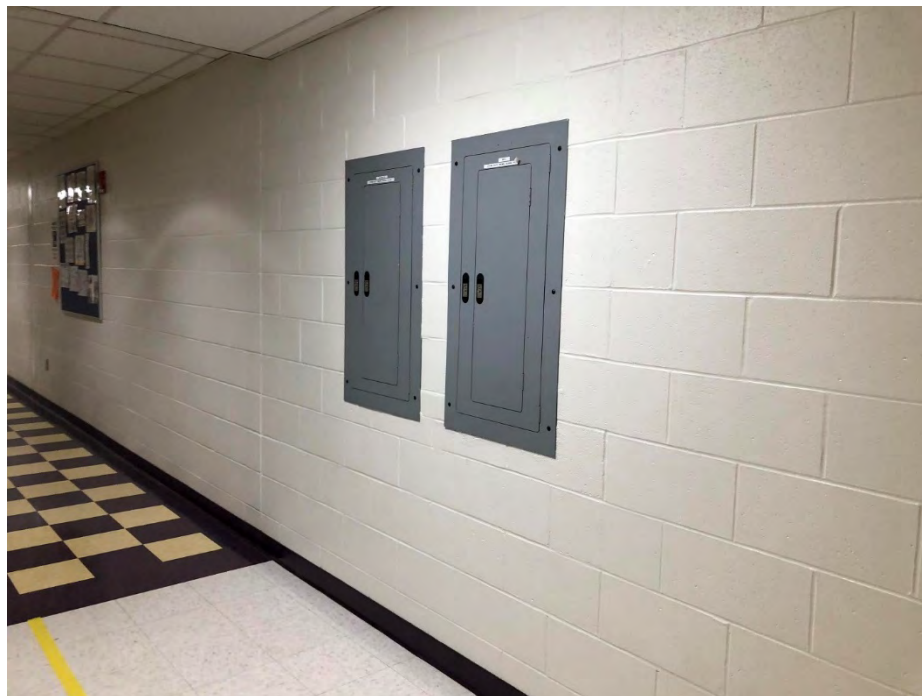
Figure E-13 Electrical Distribution System in Building 1

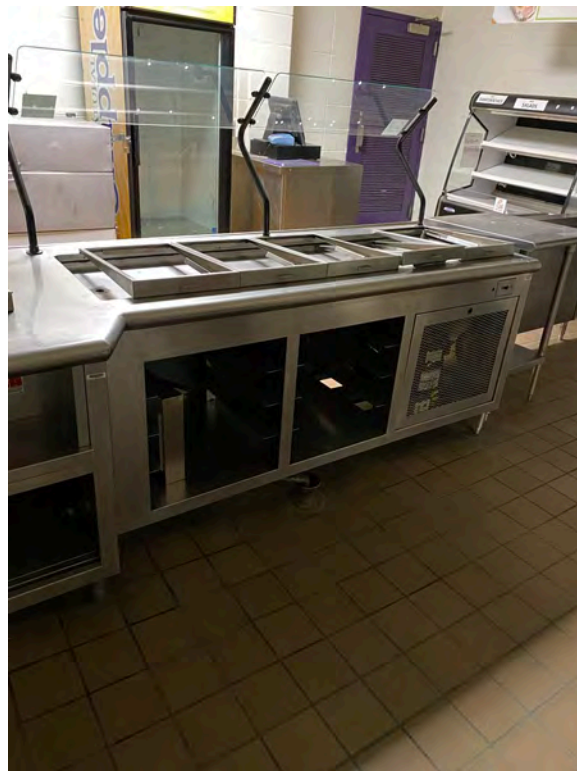
Figure P-8

- Various sinks types installed and all stainless steel.
 - Serving area sinks hard-piped to floor-mounted grease interceptor (Figure P-8).
 - Serving area equipment drained to floor drain with funnel (Figure P-9).
 - Sinks and other equipment waste piped floor sinks with air gap (Figures P-10 and P-11). Piping continues to lower level to floor-mounted grease interceptors installed in storage room (Figure P-12).
4. Sprinkler heads in this building are mixed between concealed pendent heads (Figure FP-1) and semi-recessed pendent heads (Figure FP-2).
 5. Single roof drains are installed in multiple locations to remove storm water from flat roof area (Figure P-25).

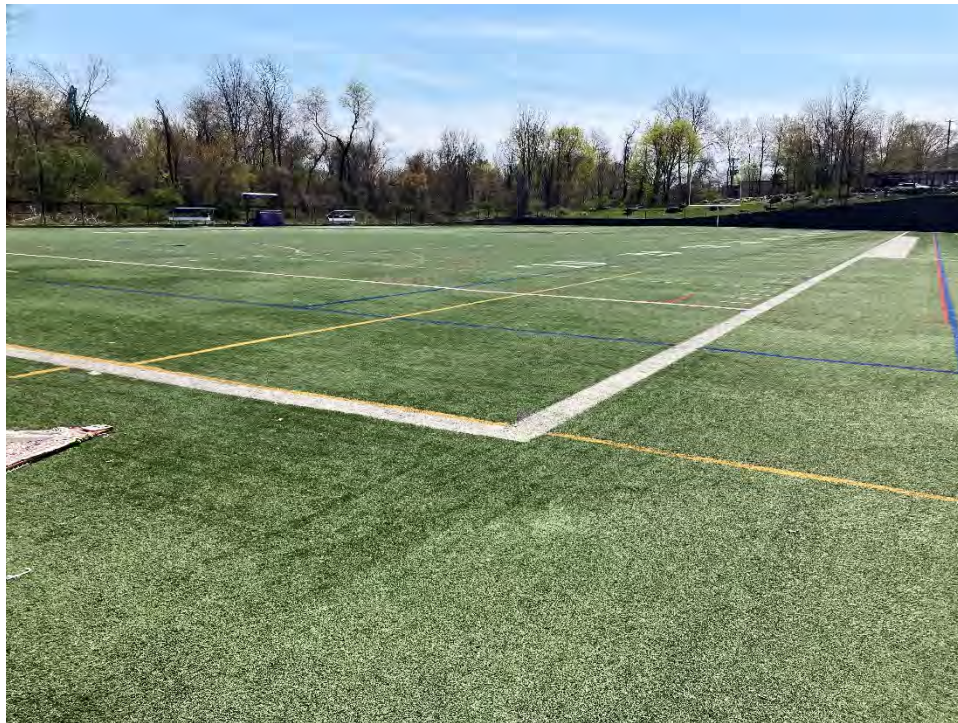
Photo 1: Lower Synthetic Turf Field

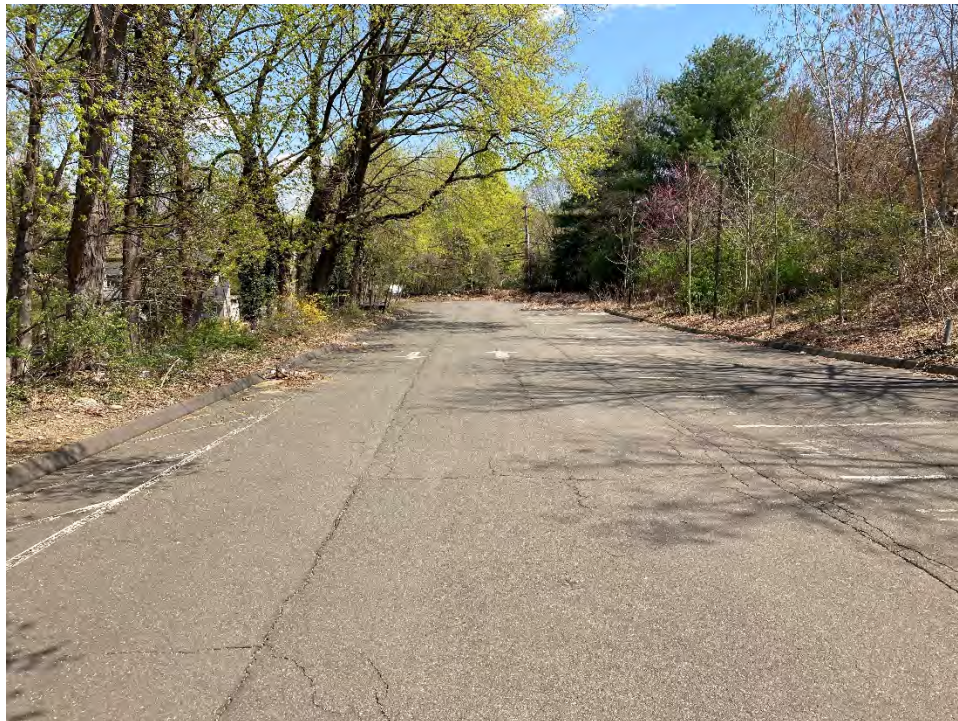
Photo 2: Dead End Parking Lot Drive

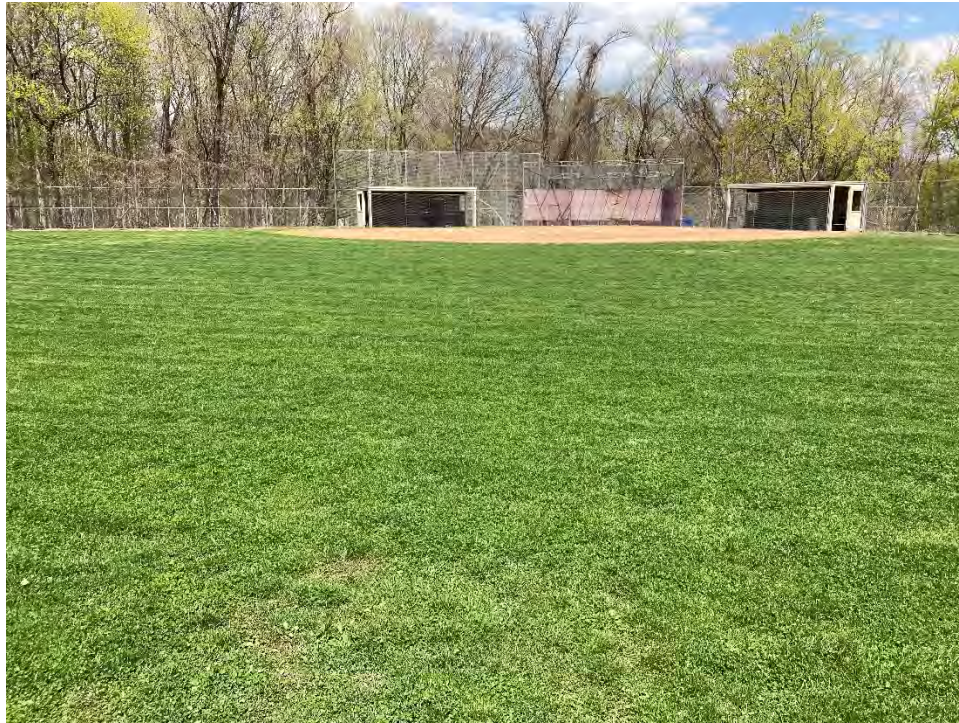
Photo 3: Allison Rioux Softball Field

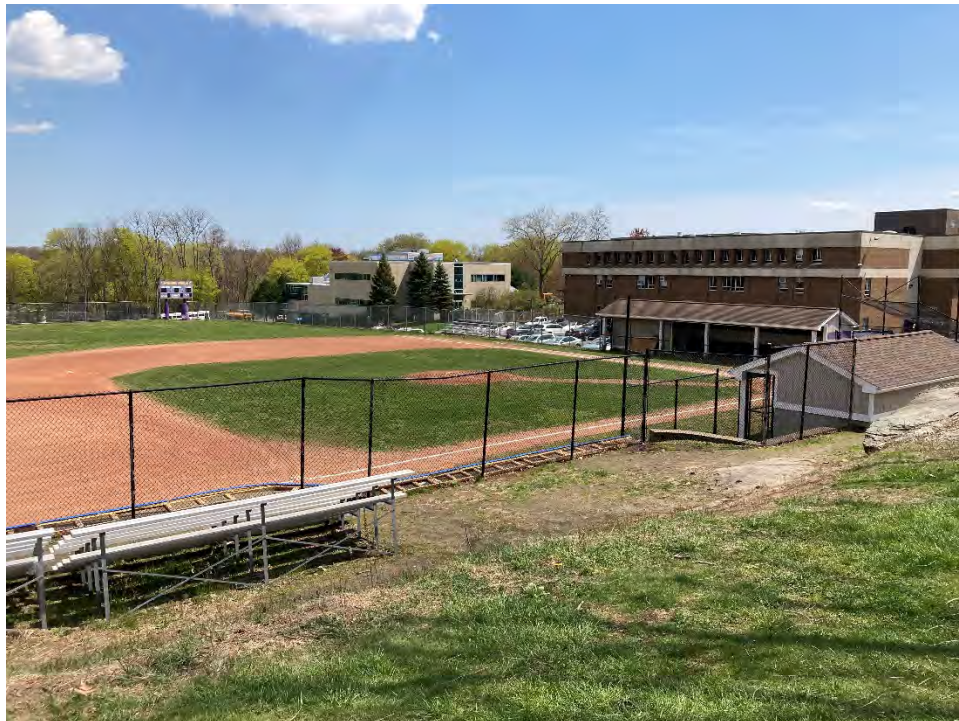
4. The dugouts are timber frame construction and appear to be in good condition.
5. The is a batting cage beyond the leftfield fence.
6. The spectator seating area is beyond center field and is elevated sitting on top of a modular block retaining wall. The seating consists of portable bleachers which are not accessible.

Photo 4: Viking Field - Baseball

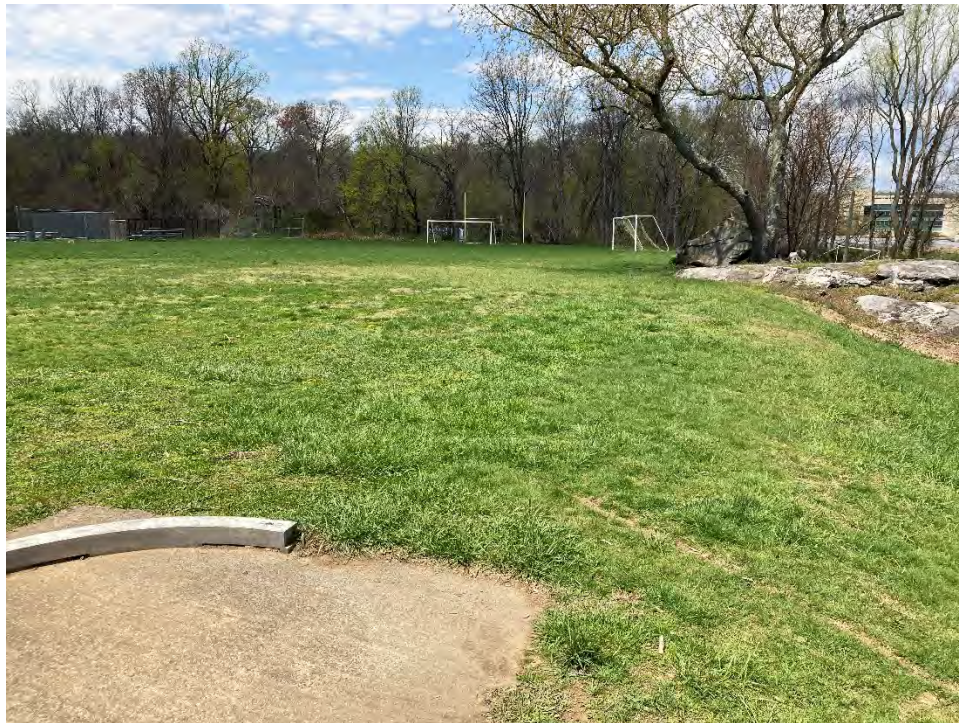
Photo 5: Utility Field – Football, Discuss, Shotput

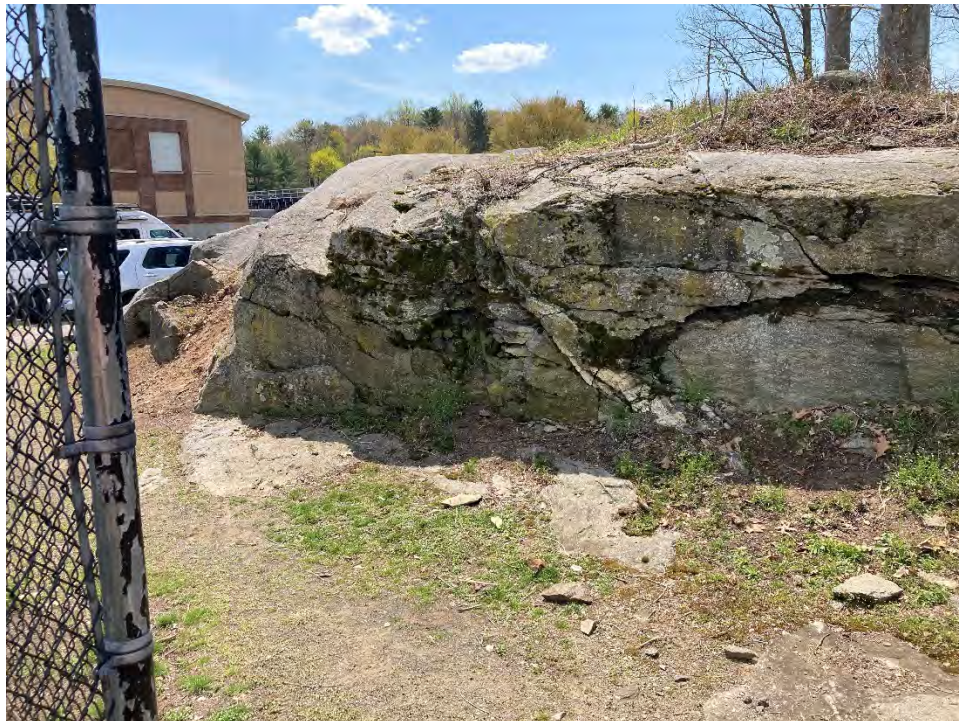
Photo 6: Ledge

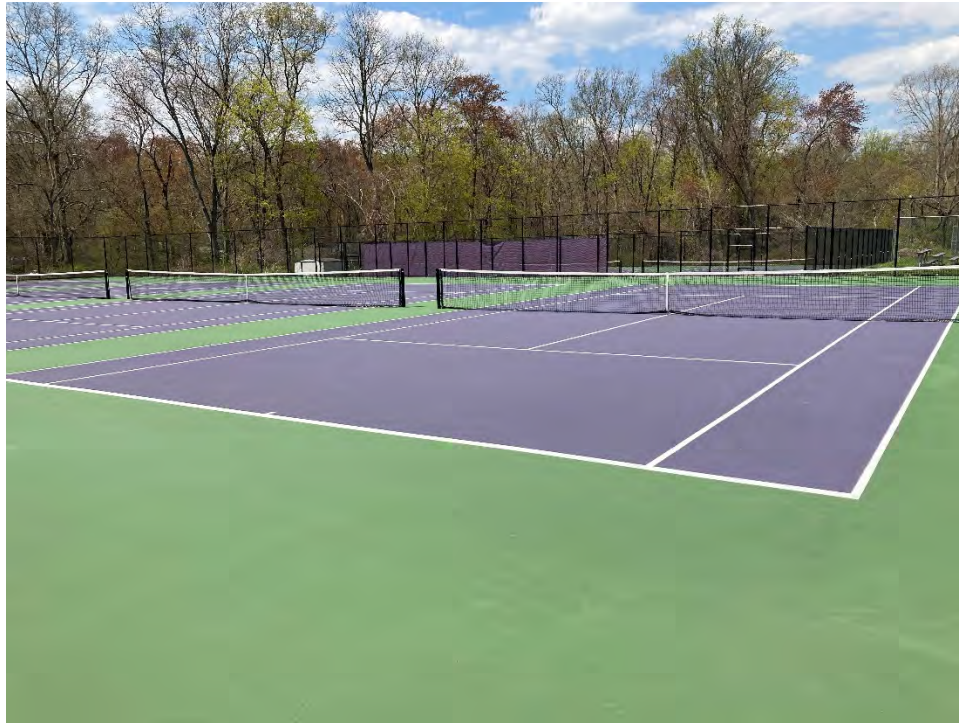
Photo 7: New Post-Tensioned Concrete Tennis Courts
