VOLUME 2 OF 2

APPENDICES

APPENDIX 5: WESTHILL HIGH SCHOOL FACILITY CONDITION ASSESSMENT

EXISTING CONDITIONS REPORT

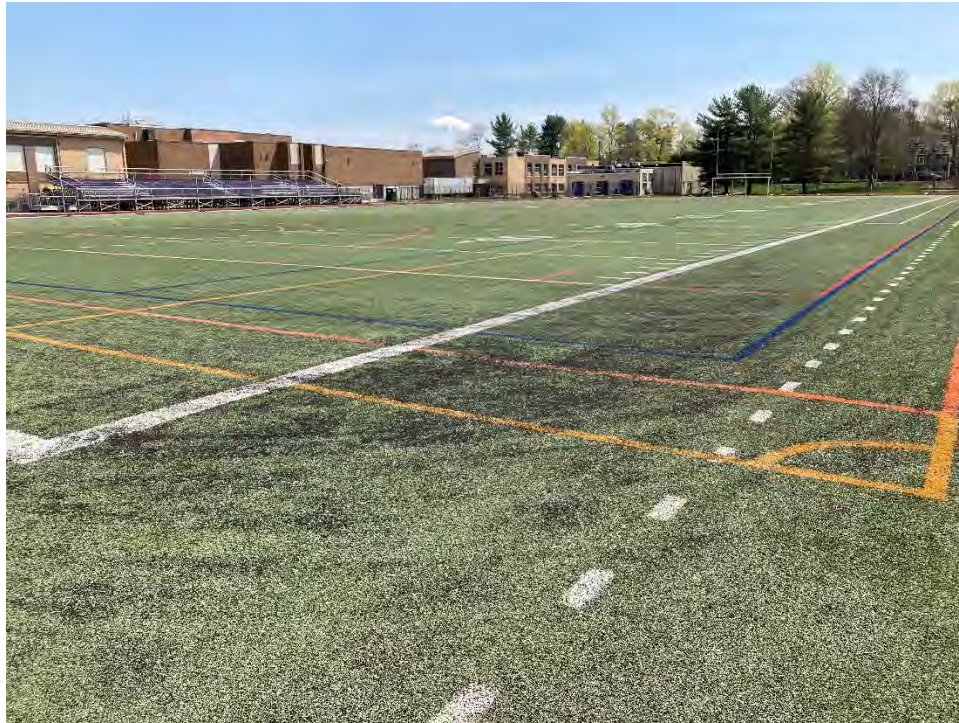
Photo 9: Synthetic Turf Field Inside Running Track

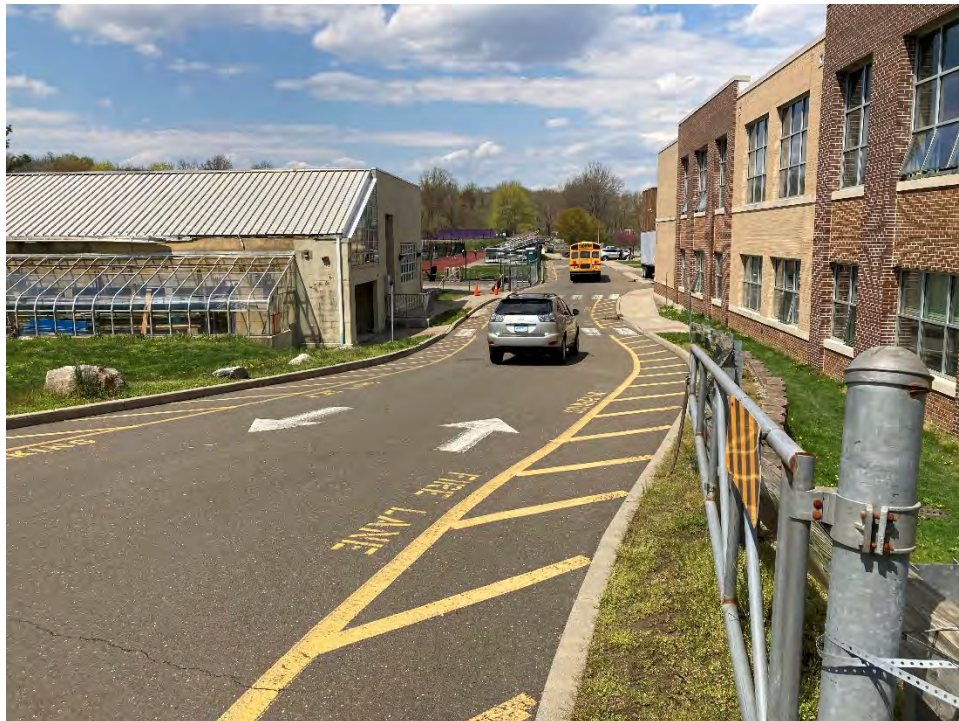
Photo 10: Gated Entrance off Roxbury Road at Southwest Corner

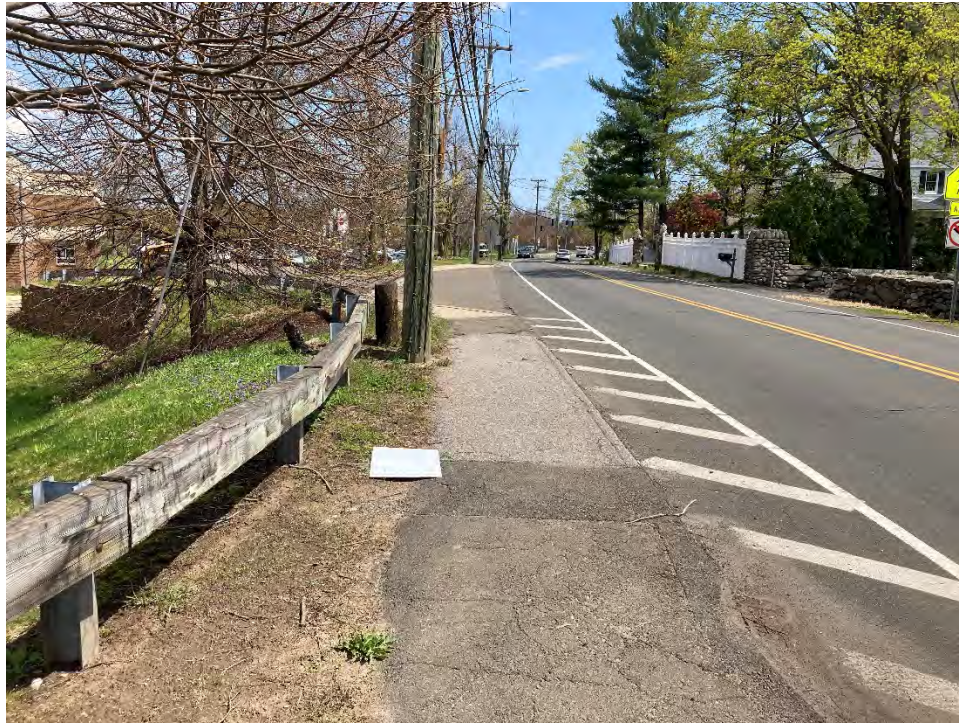
Photo 11: Walk Along Roxbury Road

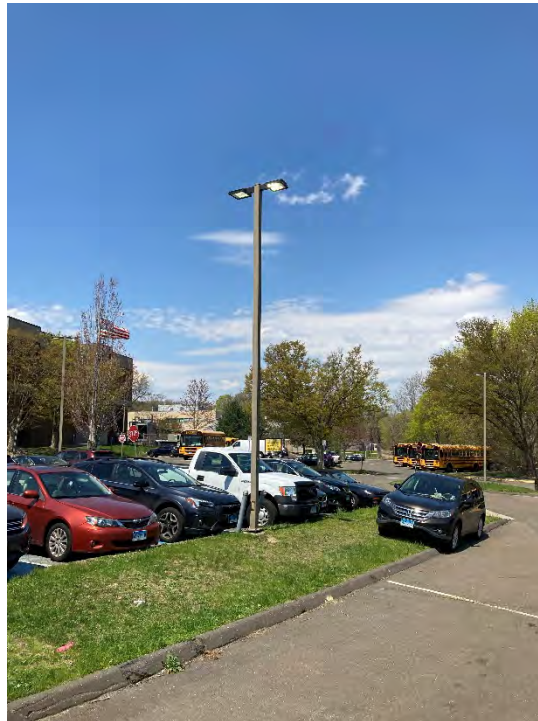
Photo 12: Standard LED Area Light in Parking Lots and Along Driveways

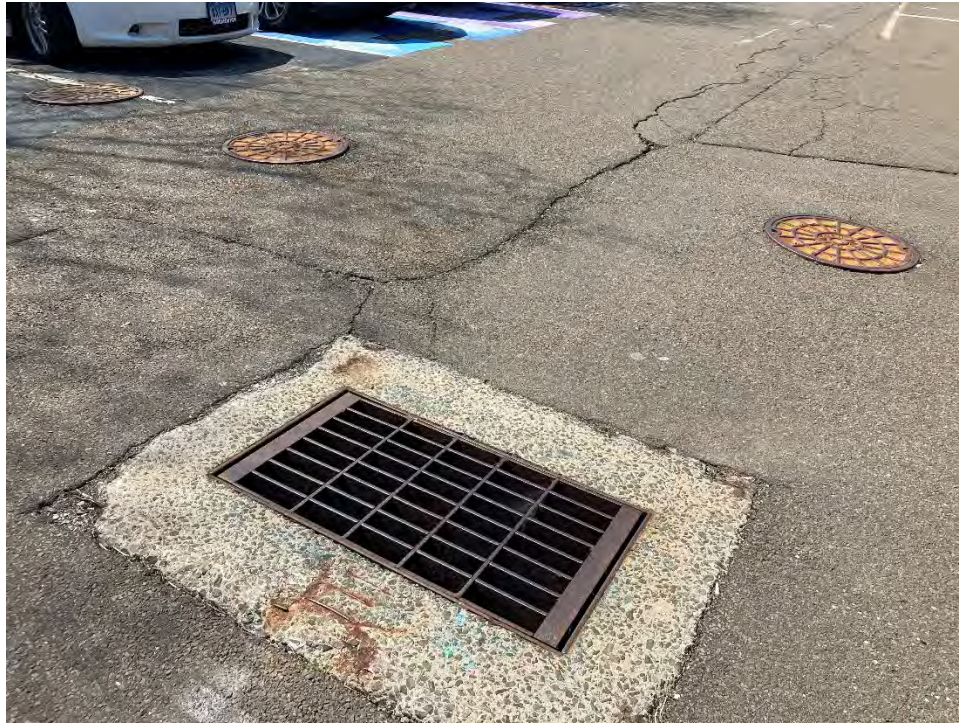
Photo 13: Typical Catch Basin and Storm Drainage Manholes
